Mungrisdale Common Scrub Creation Report

Executive Summary

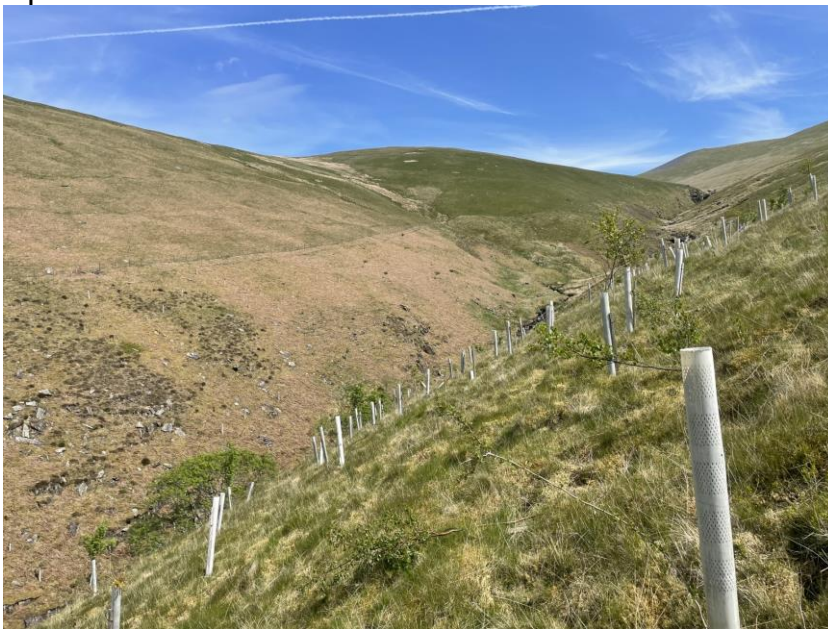
Re-planting following the Natural England inspection and the early beat-up planting has created a rather dense planting in the lowest part of the compartment, with few trees at the top end, the last restock concentrated on planting new trees further up the compartment, which has been successful with around 80% success, although alive the growth rates are slow on the 2020 restocks, with birch only just emerging from the tubes and the Hawthorn at only 90cm to 1m in most cases . Wind damage has continued to be a problem here, and 5-10% of tubes require some “righting” & repairs. The most concern comes from the left side of the gill looking up, this mid section along with the top area of the gill has the majority of the losses and only a handful of slow growing successful trees. This area suffers from High wind exposure, lack of soil to stabilize guards, lack of nutrients and soil for the trees and prone to drought through the summer. Stock trespass has appeared to have stopped resulting in great growth rates on the more established trees and a noticeable vegetation change . Damage to water gates from high water flows and vandalism has not occurred as with previous reports, which is a positive outcome for the project. The fences while currently stock proof have a very short lifespan left. Signs of extreme post rot and some snapped posts, including strainers have started to occur. This compartment will need work to comply with Natural England expectations.

Compartment 1. Roughten Gill righthand side. You can see the left hand side is already droughted out, and nearly all trees have failed on that side.

Cpt 1 Remove fallen tubes from site to tidy them up and keep the site looking good. The guards are as likely to kill the trees in some of these sections as the wind is folding them over preventing growth. To complete the scrub numbers and dispersal required the use of larger 60-90cm trees to be planted unguarded would be recommended, Rowan, Hawthorn, willow and Alder would be suitable for this, and may allow slow regeneration of the poorer soil and exposed areas of the compartment. This is a lower cost solution with ideally 1500 trees to be planted to ensure we have enough survivors to populate the compartment. The fence is currently standing, so monitor for sheep ingress and repair the gaps as needed.

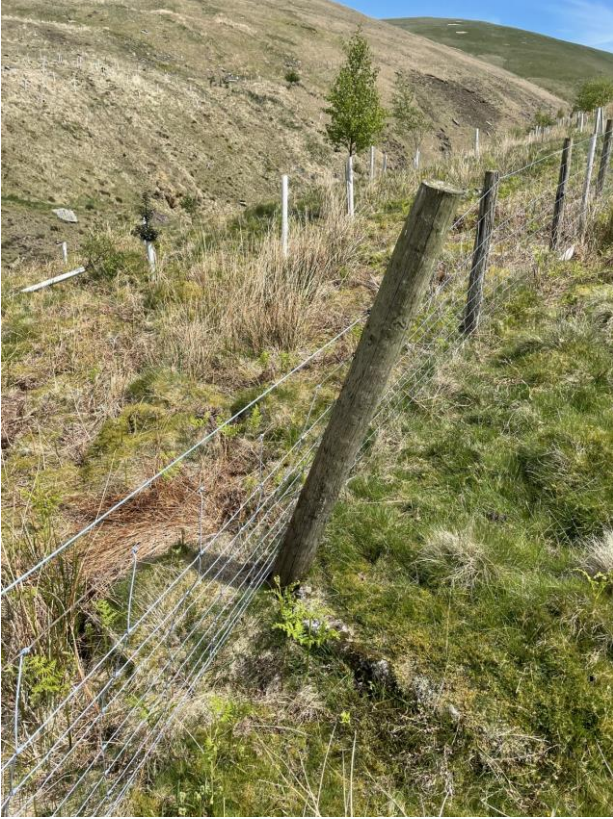
Failing Strainers and posts are similar on all fencelines.

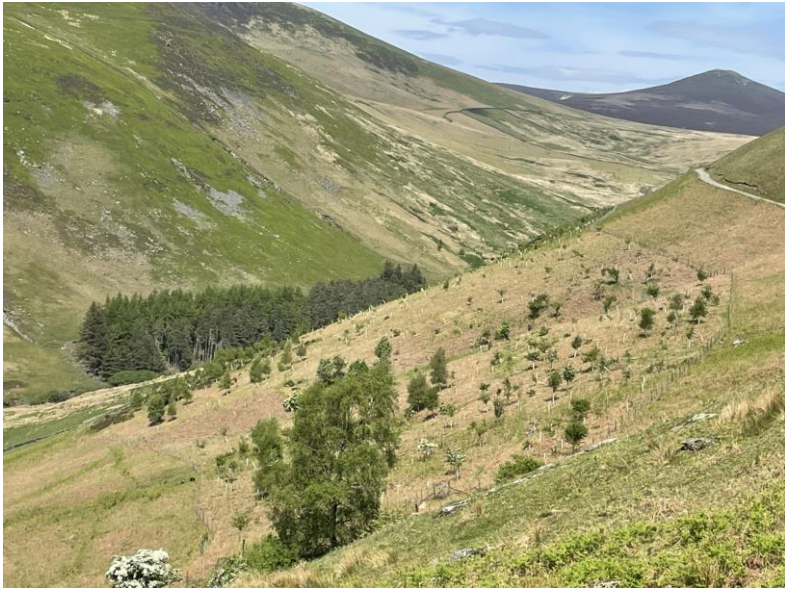
Glenderterra Compartment 2.

This section is currently fully stock proof, as a result the trees particularly birch, rowan & hawthorn have had brilliant growth rates. The attrition rate is low here, with only a handful of the 2020 restock trees failing, accounting for some empty tubes on site. This compartment is meeting the goals of the scheme, and the 2020 replacements are showing good signs of being established to the point they are safe from sheep in the next 2 to 3 years.

Cpt 2 Monitor for sheep ingress, remove sheep and repair gaps as needed.

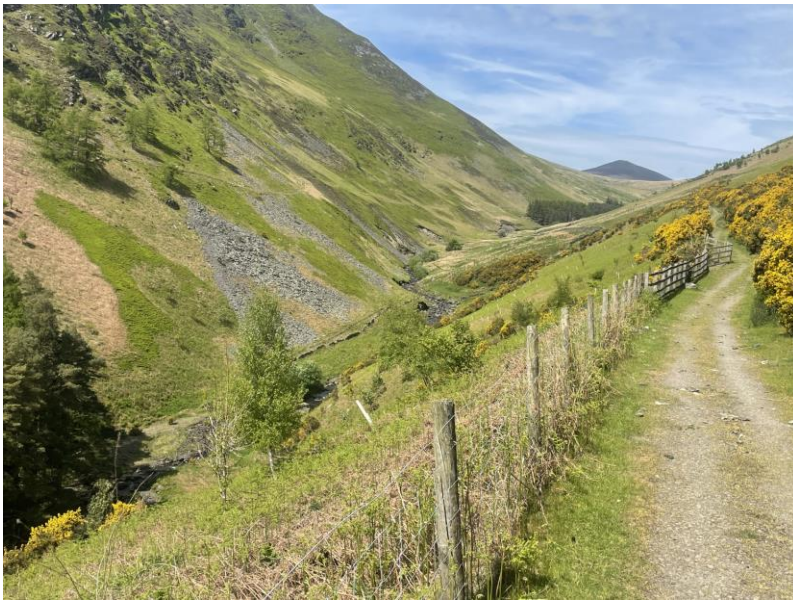
Glenderaterra Compartment 3.

This compartment has great growth rates on the established trees, and was clear of livestock the day of inspection, although has had some short term stock ingress by sheep at certain points within the year, these had been quickly removed, and no damage to the trees or vegetation were noticeable. The fence has started to fail, with the posts rotting and the staples falling out of the posts as they dry out. No gaps visible or sections requiring immediate attention. The site probably requires around 150 trees (10%-15%) to hit its original target, and the site has a large bracken bed in the center that has very few trees within it. The bracken is so dense here that it has likely caused previous losses, resulting in the scrub being around the boundary of the compartment, but doing very well. Natural regeneration of gorse has swamped some sections of trees, with the trees only visible as they emerge from its canopy, this is currently adding diversity to the site and protecting the trees, but may cause issues going forward, increasing fire risk and access issues. This site is on the border line of passing a Natural England inspection, They may be happy with it if they deem the gorse regeneration as a positive scrubland outcome.

Cpt 3 The only section requiring trees is in the bracken bed on the steep section, establishing trees in here has proven difficult. The recommendation would be to use 100 of 90-150cm trees planted without guards to out compete the bracken. A mix of hawthorn and alder would be recommended as they are naturally more resilient to the deer grazing. The gate at the far end of the track needs a chain, and the fence could do with some staples put in to keep the wire attached. Then monitor for sheep ingress and fix gaps as needed.

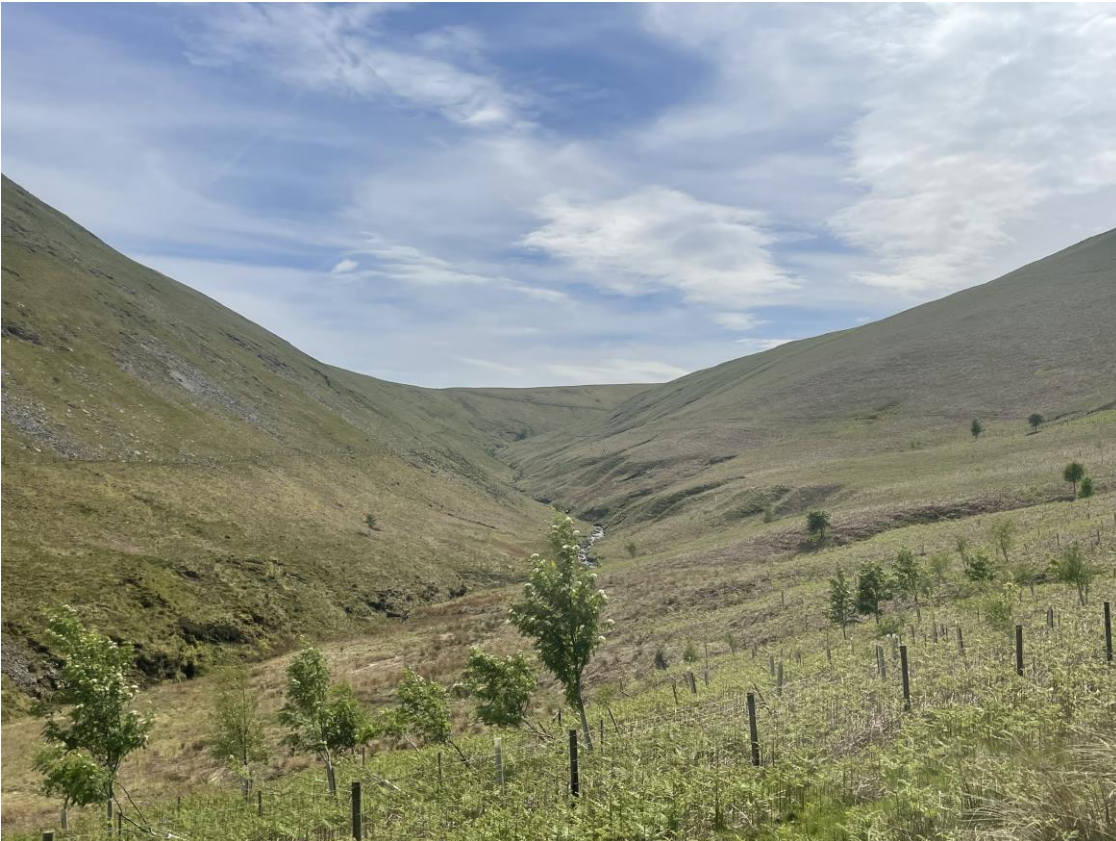
This is the largest compartment and perhaps the most visited by the recreational users of the Common. The trees that survived the original planting are again doing very well here, with the birch and rowan to 15ft and hawthorn well above the tubes, although there are large sections of failures and poor growth rates. There are a no gaps under the fence where sheep could enter the enclosure, and the water gates are still performing well, the top upstream

Glendermakin Compartment 4. Strong established trees in the foreground, but very few trees on the right hand side bracken bed. Even fewer trees on the left hand side of the stream where there is only a thin layer of soil on top of free draining aggregate.

Cpt 4 Remove fallen tubes from site to tidy them up and keep the site looking good. To complete the scrub numbers and dispersal required the use of larger 60-90cm trees to be planted unguarded would be recommended, Rowan, Hawthorn, willow and Alder would be suitable for this, and may allow slow regeneration of the poorer soil and exposed areas of the compartment. This is a lower cost solution with ideally 1000 trees to be planted on the right side of the beck. In the Large bracken bed the use of larger 90-150cm trees without guards would be recommended. Mainly using Hawthorn to resist against deer. Planted in dense clumps of 50 to create self protecting pockets of scrub. The fence is currently standing, so monitor for sheep ingress and repair the gaps as needed.

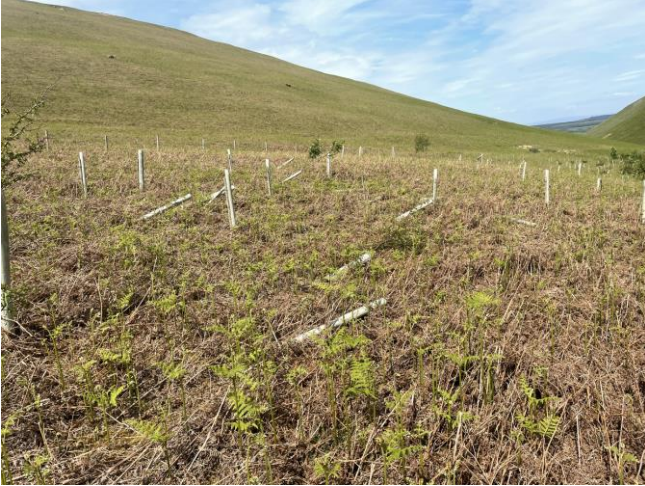
High winds have also occurred here, knocking over or de-stabilizing trees and tubes, along with deep bracken beds . Approx. 10% of tubes require re-staking or removing. The success of the largest trees are located close together creating a strong section of almost woodland density, the trees out of this section have grown slower or have been planted in the 2020 restock. The lack of size of these trees is likely to be to do with the competition with the bracken on the left side of the beck (looking downstream) and the poor rocky, drought prone terrain on the right side of the beck. The bracken bed and the rocky section make up almost 70% of the site, leaving the site sparsely populated, and not where the expectations of the project would have hoped at this stage. Some remediation would be required, but some foundations are there. **Cpt 7 Monitor for sheep ingress, remove sheep and repair gaps as needed.**

Compartment 4 windfallen trees.

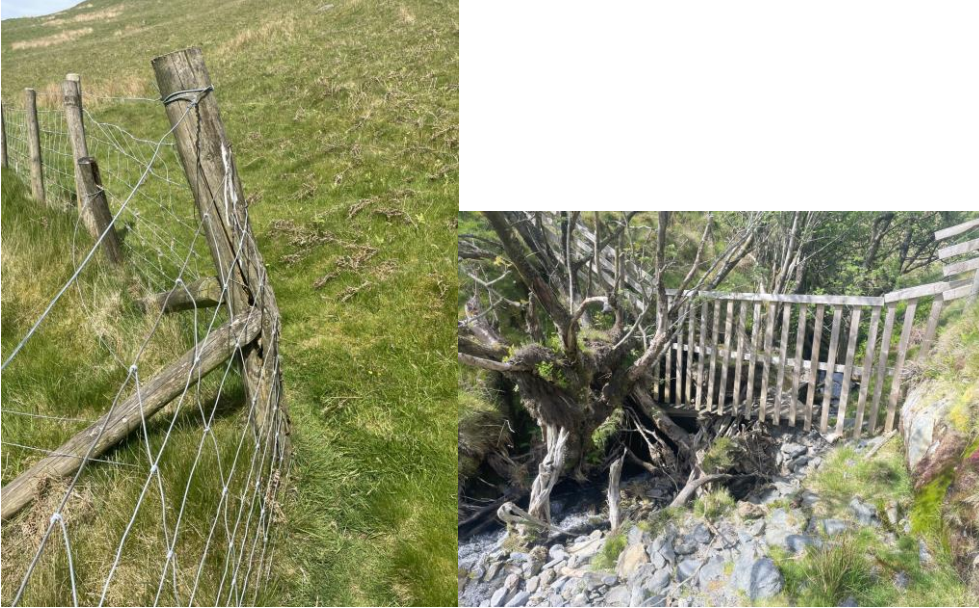
water gate has some gaps in the debris under it, but is highly unattractive to livestock, and unlikely to be of any risk to the project. The down stream water gate is intact, but erosion has made some gaps a sheep may be able to squeeze under during low flows. Some additional rails or moving around of the rocks for the summer period may be required. The fence is stock proof, but again the posts and strainers are starting to fail.

Failed strainer and undermined watergate on compartment 4.

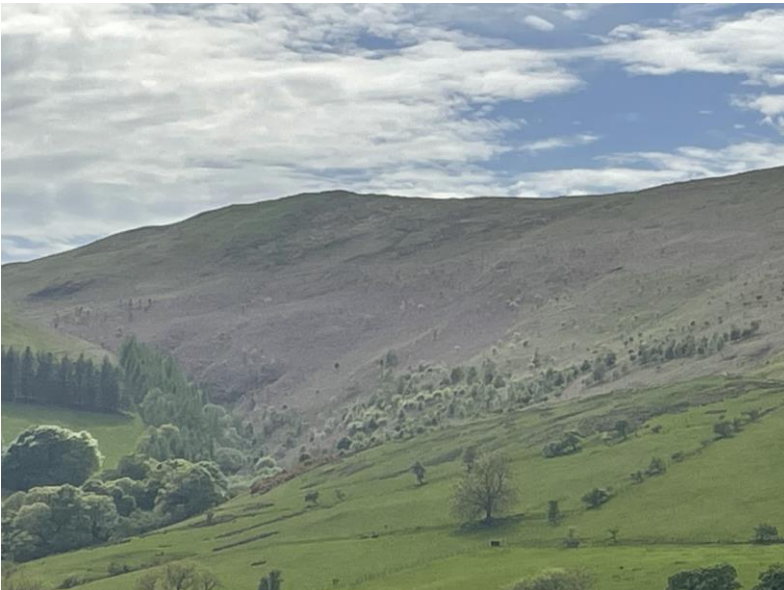
Souther Fell Compartment 5.

The birch and rowen in this compartment are doing particularly well, with trees of 10-15 ft. The wind damage to the tubes is less here, with very few tubes requiring re-staking or removing. Sheep ingress has been massively reduced since the 2020 repairs and the spread of trees across the site is highly visible from the A66. Although the site may require a handful more trees to match the exact number of the original planting plan. The success and rates of growth of the established ones, along with the dispersal across the site, would be a clear indicator of successful scrubland creation on this site.

Cpt 5 Monitor for sheep ingress, remove sheep and repair gaps as needed.

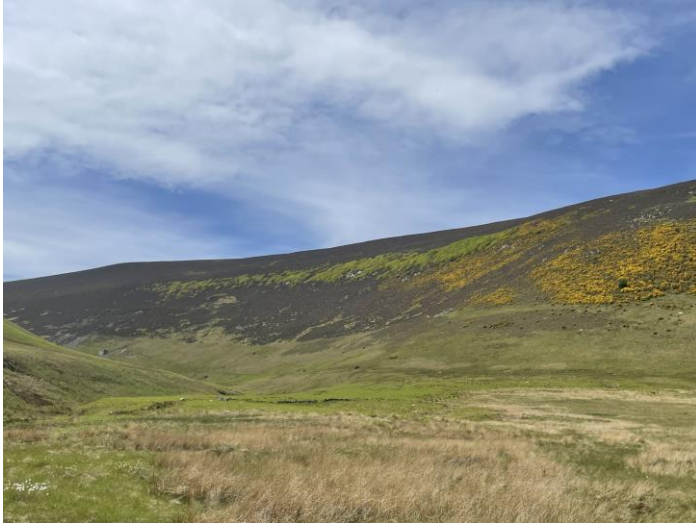
Compartment 6 Young wood.

Good regeneration is evident and compartment continues to be free from livestock trespass. The fence remains upright and stock proof, it is likely to need replacement posts and further works in the coming years.

Cpt 6 Monitor for sheep ingress, remove sheep and repair gaps as needed.

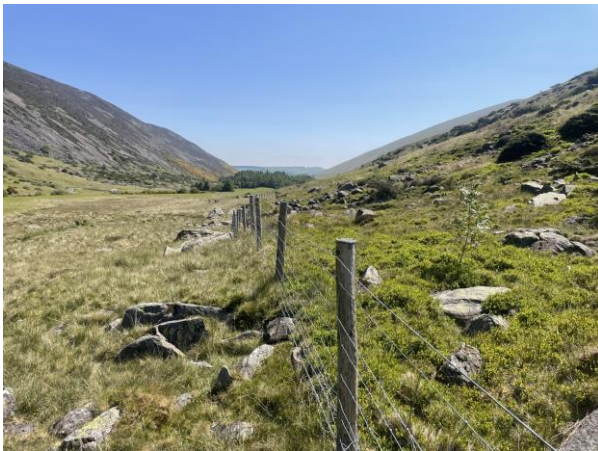
Noticable vegetation change either side of the fence

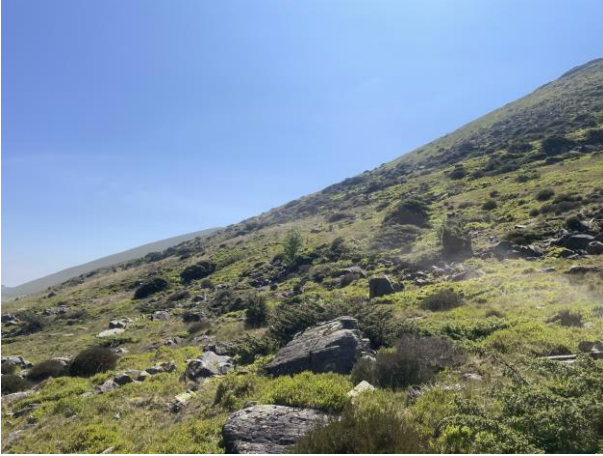
Swineside Compartment 7.

Juniper regeneration is evident in many areas within the enclosure. Billberry & heather shoots show no signs of browsing. The fence is in a generally stockproof condition all around, but again posts will need to be replaced in the coming years.

Cpt 7 Monitor for sheep ingress, remove sheep and repair gaps as needed.
