Review of areas fenced for tree and scrub regeneration on Mungrisdale, Saddleback and Bowscale Commons

Part of Skiddaw Group SSSI and the Lake District High Fells SAC

Natural England

June 2023

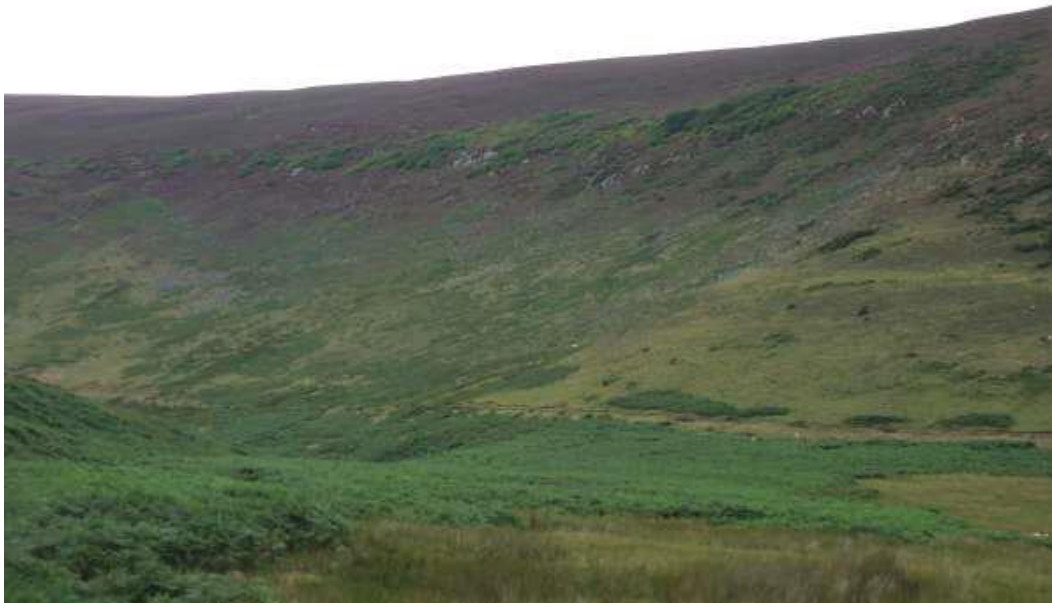
Photo from 2007, before fence installed.

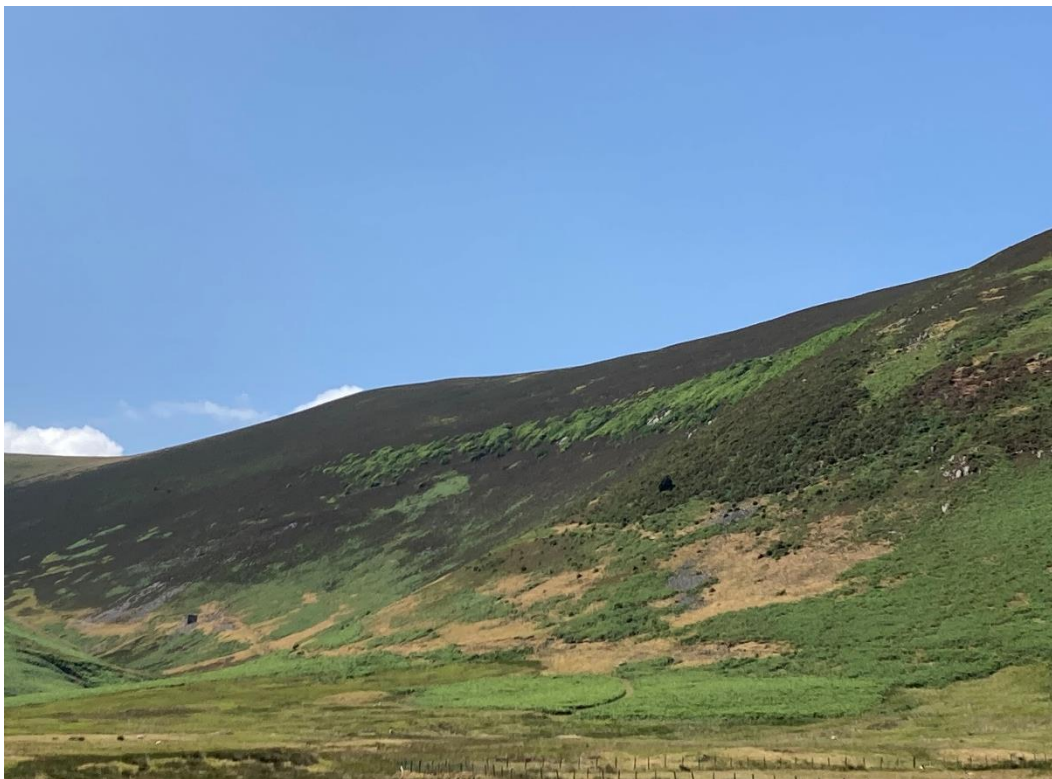
Similar view in 2023, alot of spread of heath in enclosure and possible widening of woodland itself.

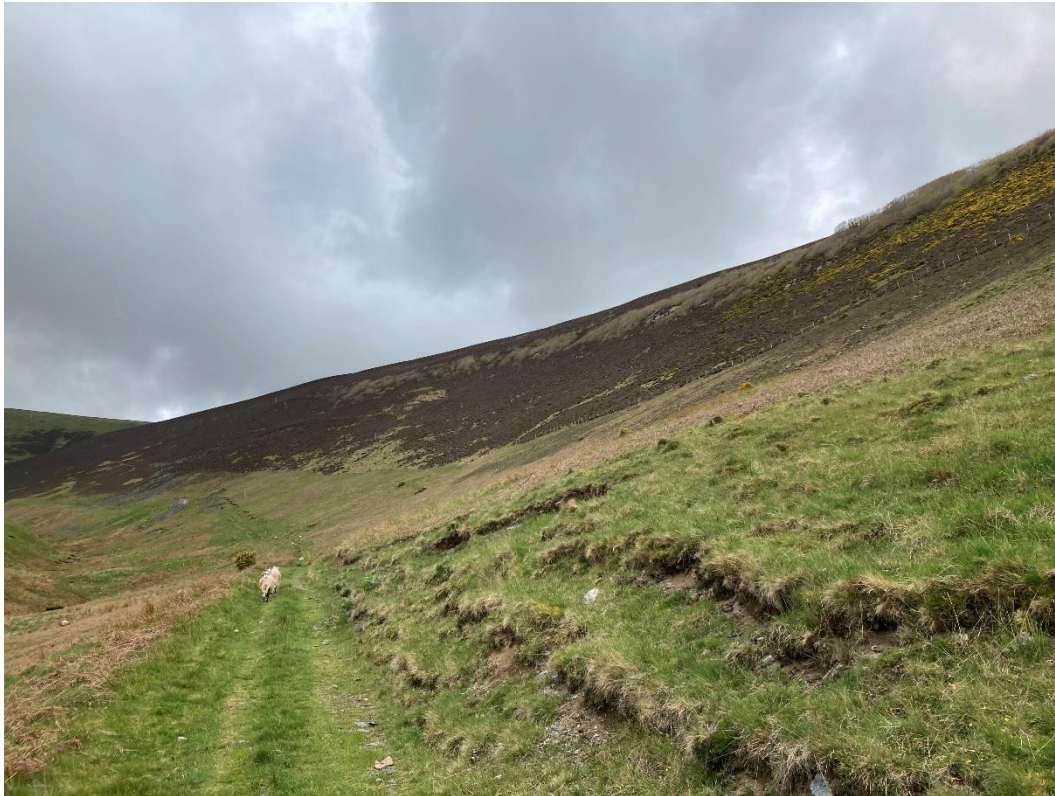
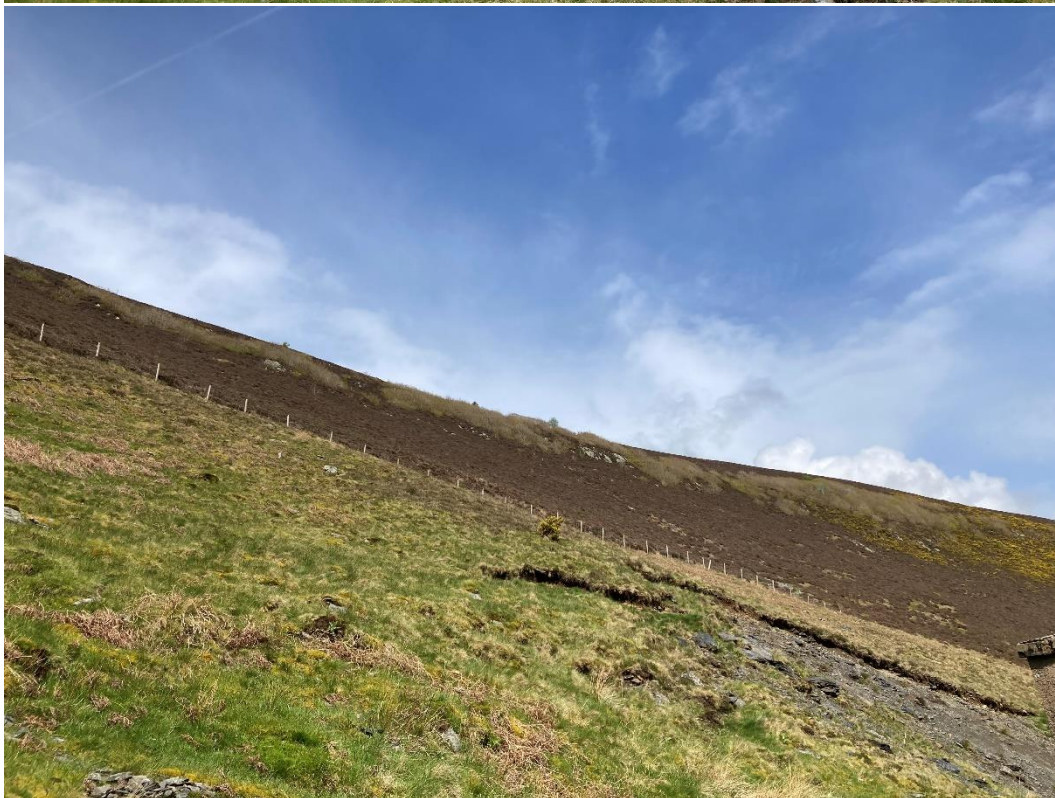
Beyond the current woodland extent, there is clear differentiation in vegetation above and below fenceline along the base of the enclosure, demonstrating its impact in allowing heath to recover away from grazing pressure.

View of enclosure from footpath. Clear difference in vegetation. Overtime, as the woodland spreads further, this habitat will be more visible for visitors to appreciate.

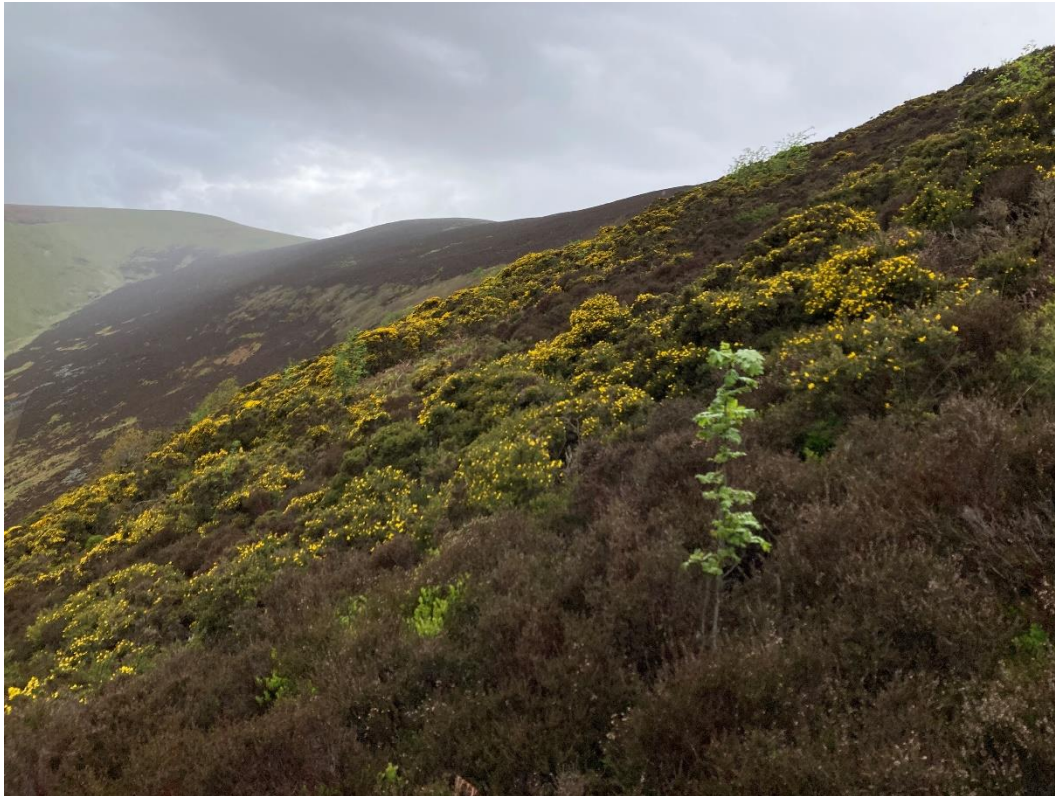
Lots of regeneration, particularly rowan saplings, and growth of dwarf shrubs.

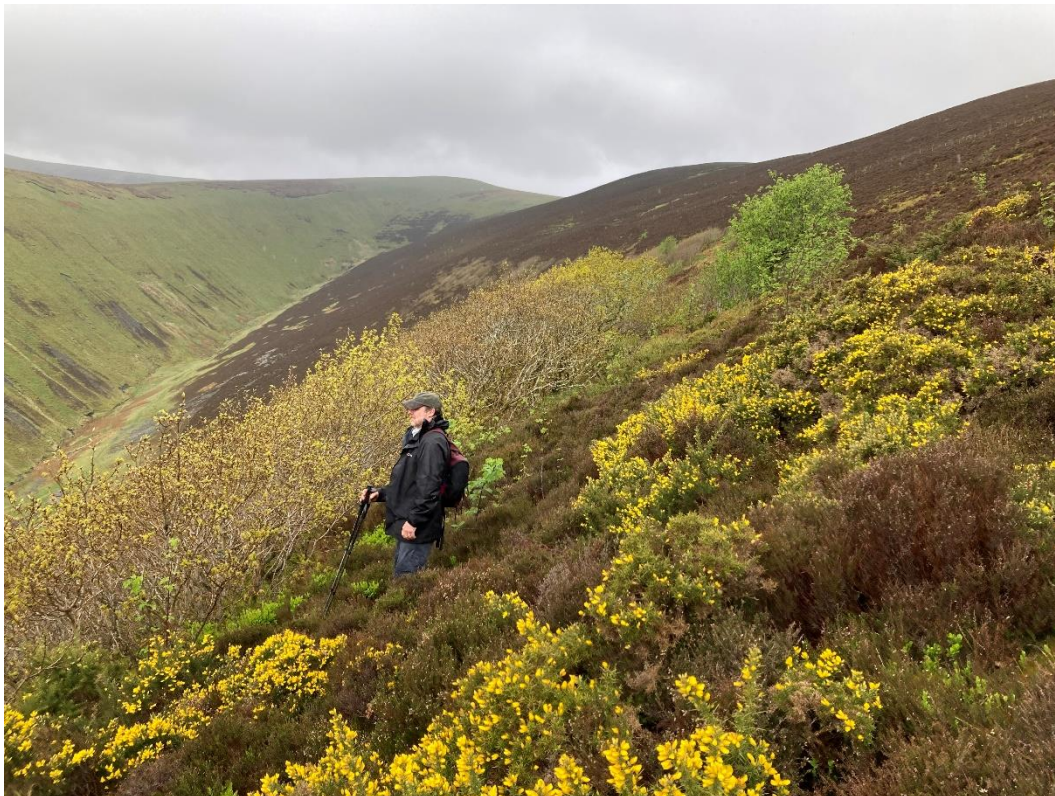
Young trees (rowan and oak) found growing above main block of woodland towards upper fenceline.

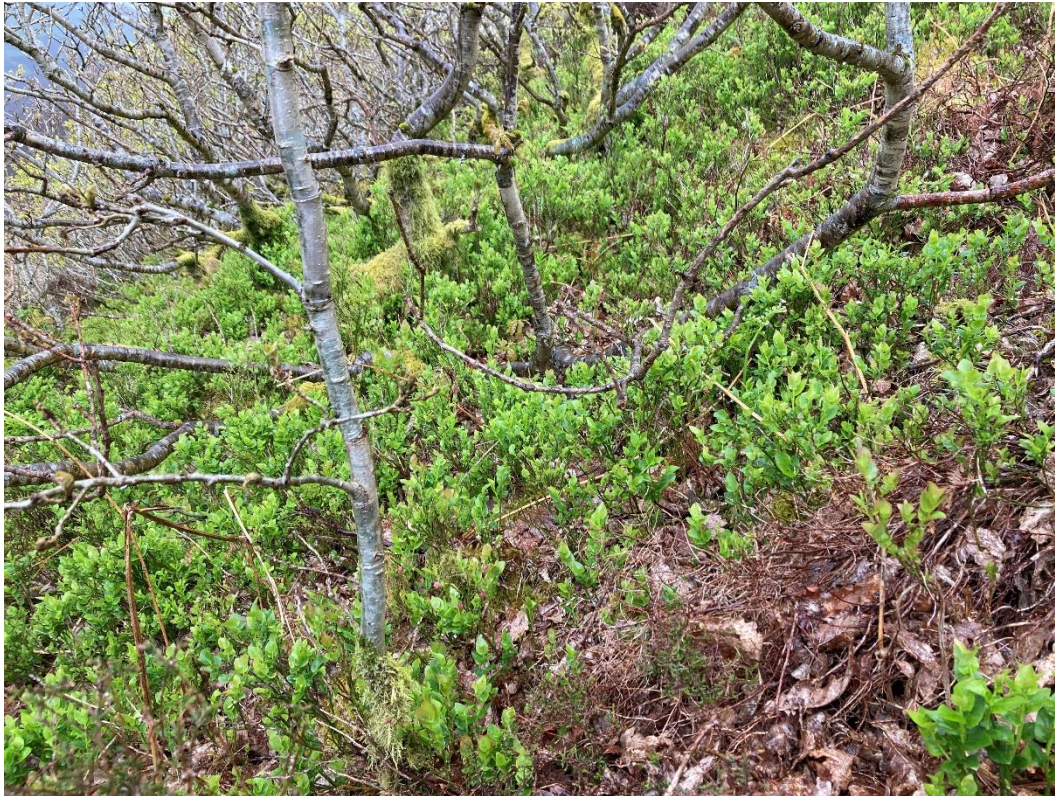
Healthy understorey with bilberry dominant and oak tree growth of varying ages.

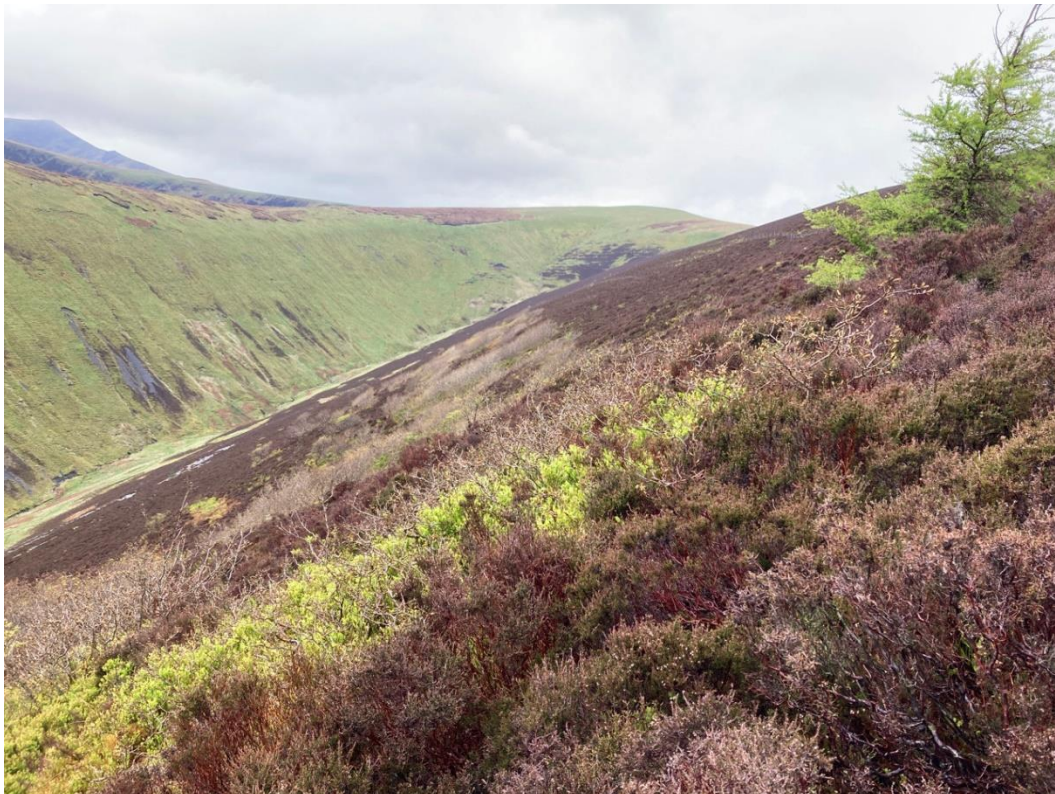
Areas of shorter oak growing above main woodland unit, potential new growth from root extension. Conifer to be cut or ringbarked.

The occasional large conifer requires removal (or ring barking).

this should be planned and implemented in a timely manner. Likewise condition of fences, gates and water gates should continue to be routinely assessed and maintained. Particular attention must be paid to Glenderamackin to remedy the particular problems that have occurred here. The occasional large conifer in Young Wood requires removal (or ring barking).

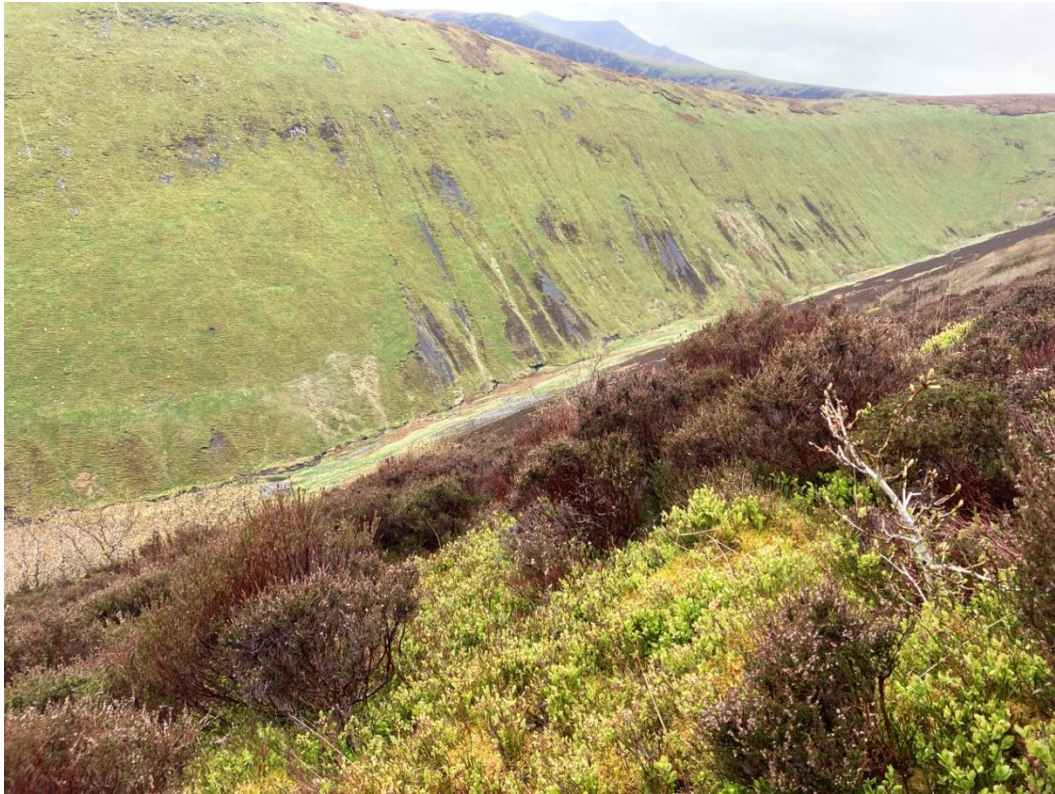
Young oak found 20m from main woodland block, possible regeneration from acorn.

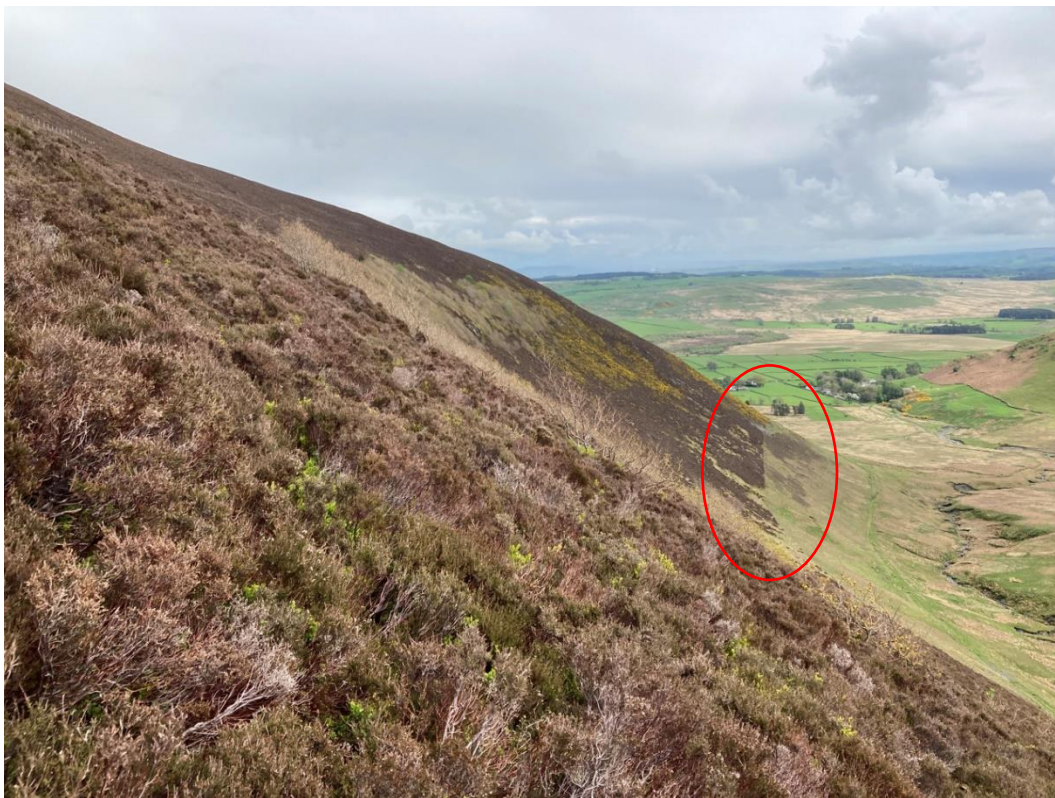
Marked difference in vegetation at lower fenceline, demonstrating benefits of enclosure in allowing woodland regeneration and recovery of dry heath.

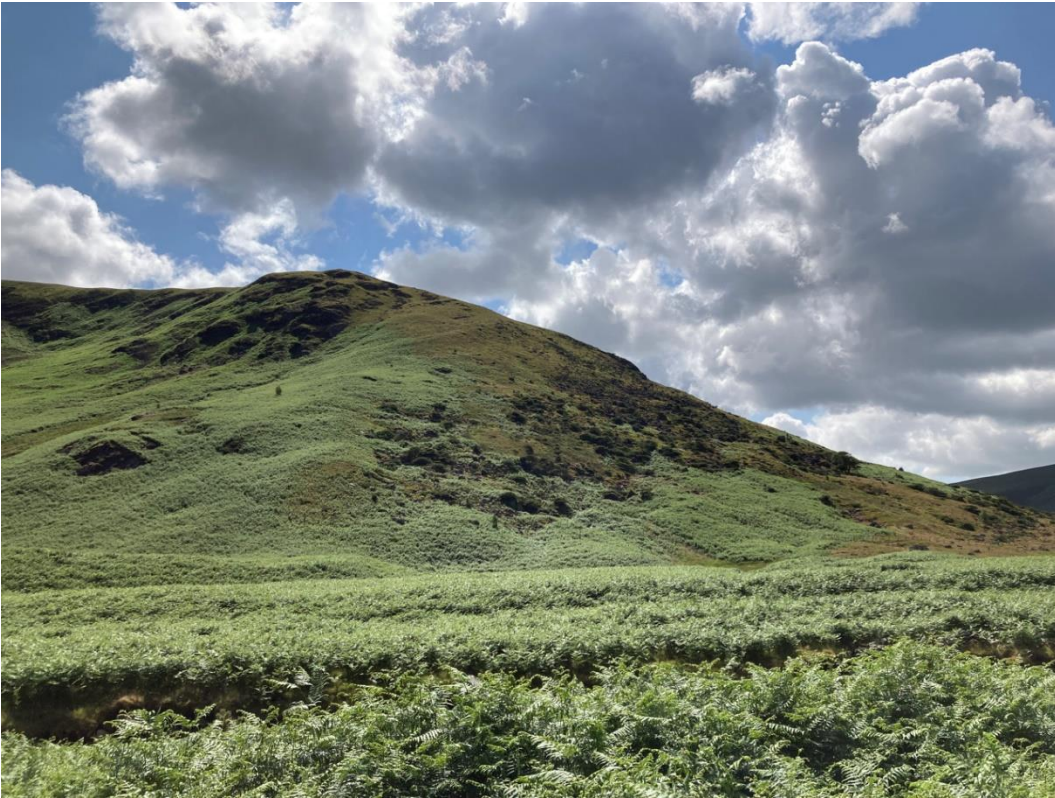
A large bracken stand along the eastern boundary conceals the fenceline, but appears not to be precluding juniper restoration.

Juniper scrub abundant in enclosure. Fenceline concealed by bracken bed.

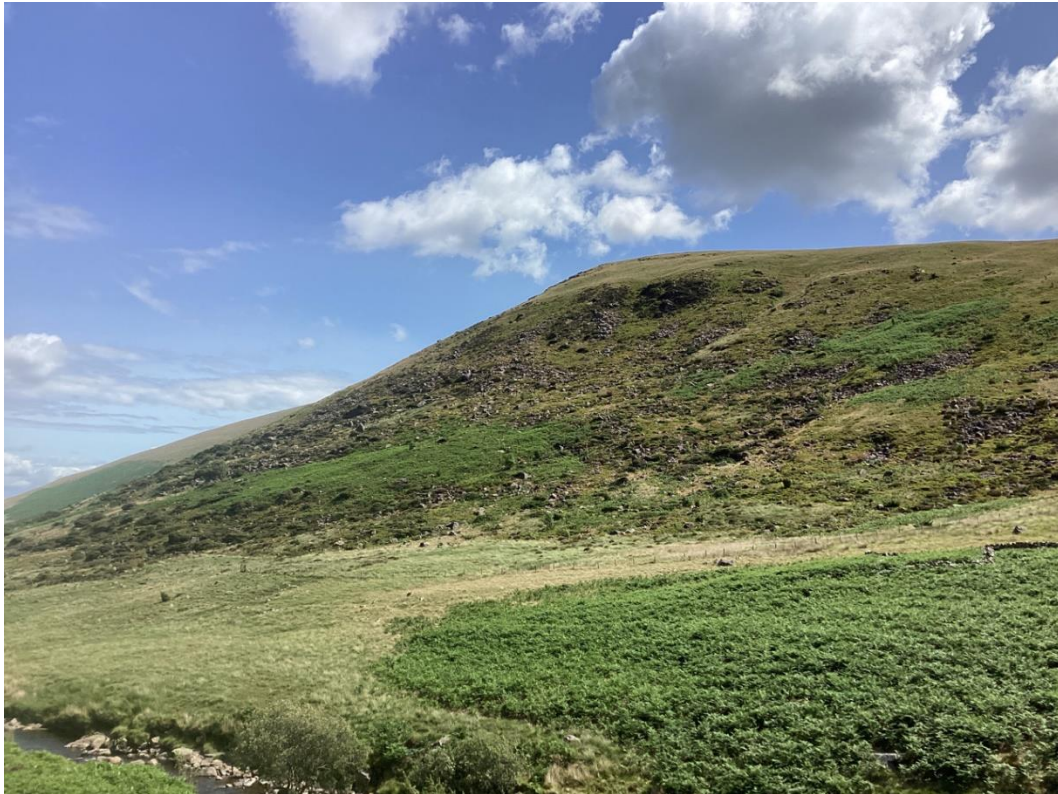
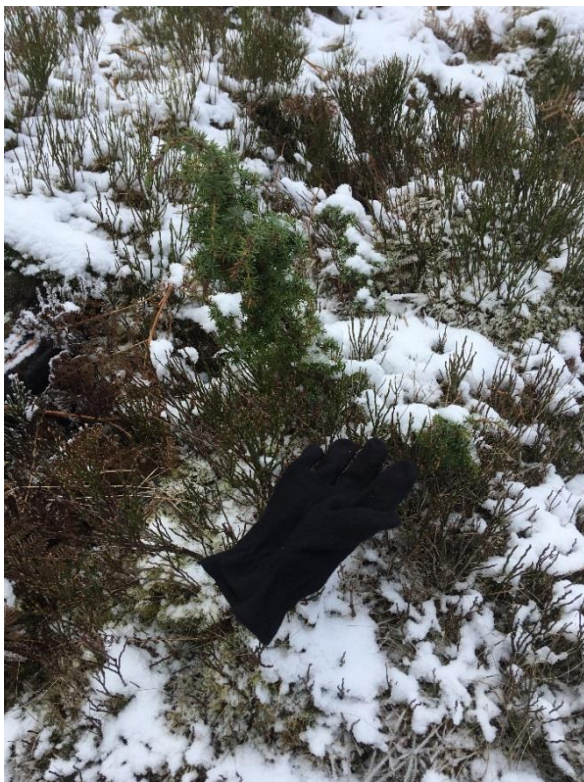
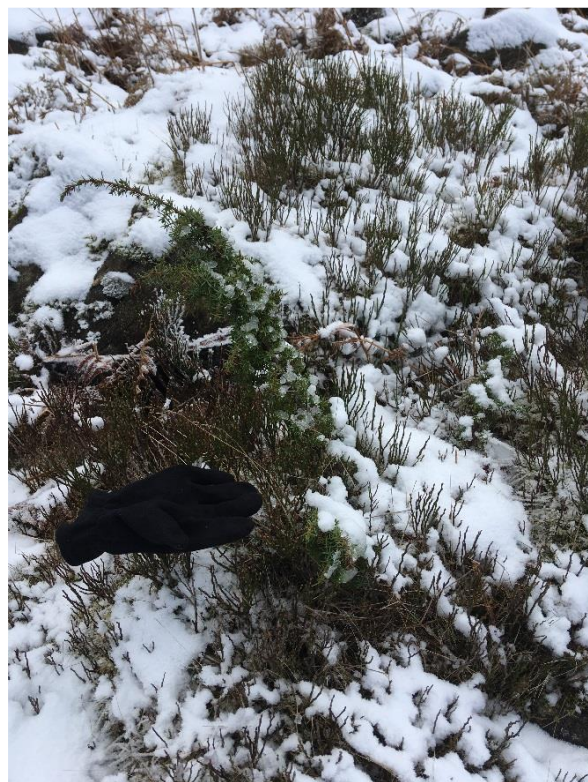
Photos taken by Rob Vatcher in 2019 of young juniper plants showing successful natural regeneration.

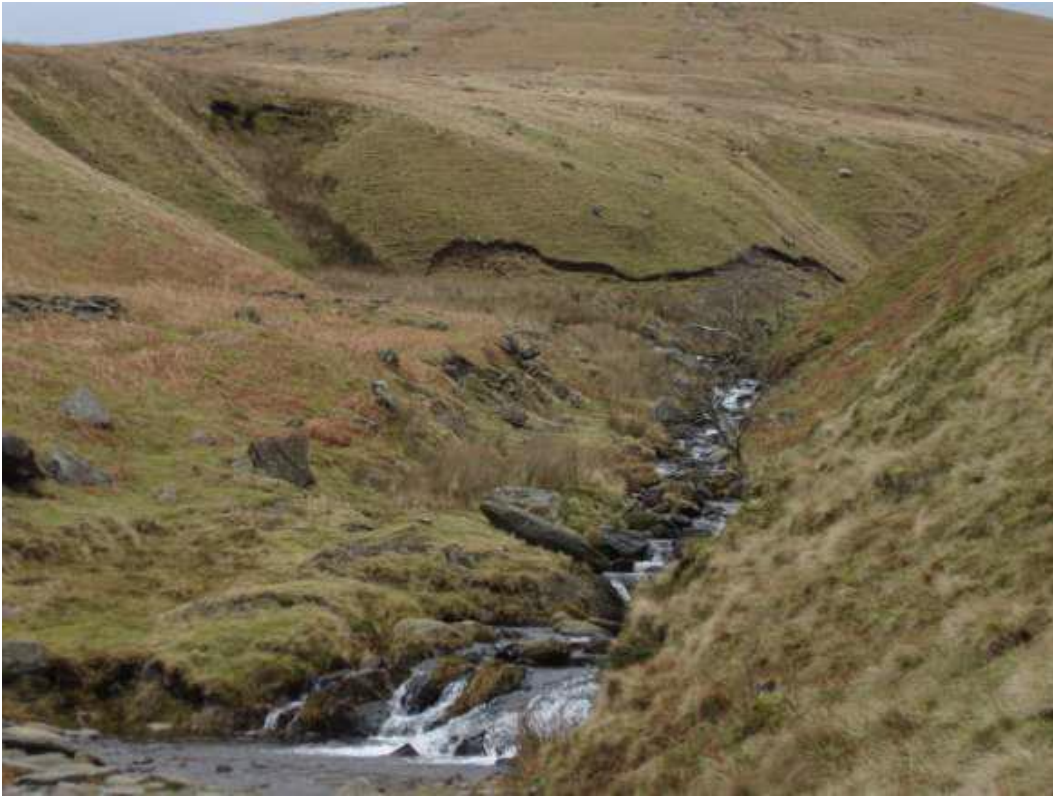
Photo from 2007, before planting and enclosure

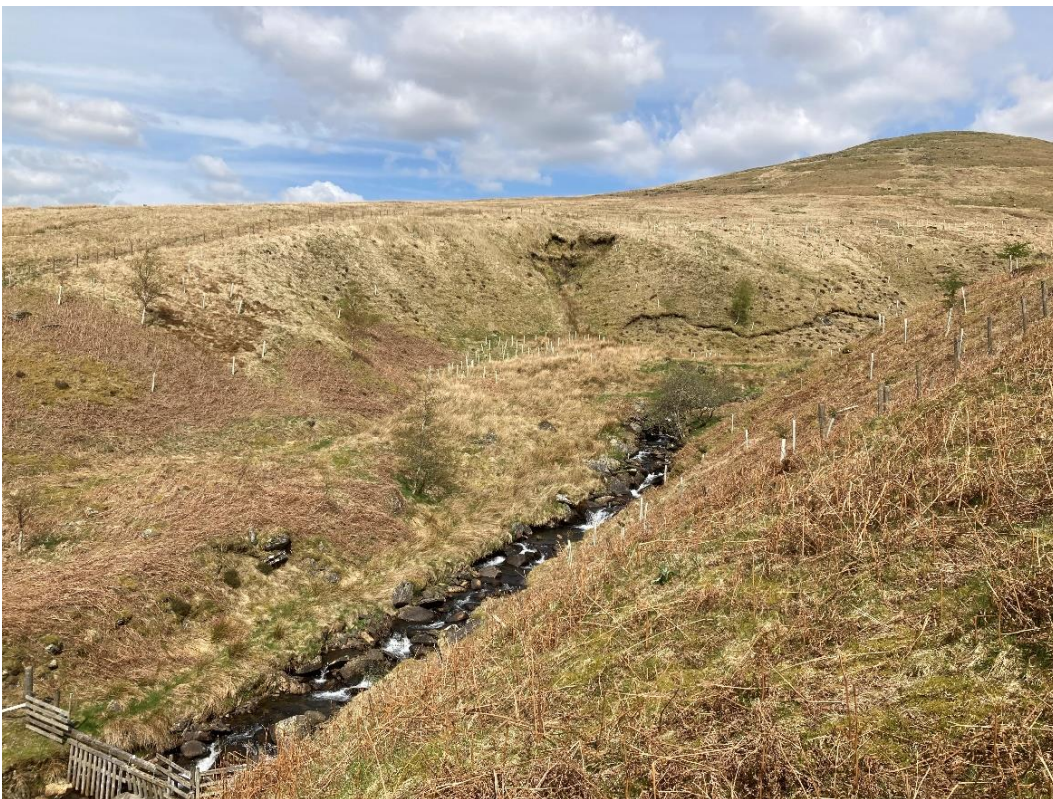
Compared to previous photos some erosion scars appear to be stabilising, with more vegetation covering them.

Similar view 2023, following 15 years of enclosure. Note tree growth, covering of erosion scar and heather growth (dark mounds) on north slope.

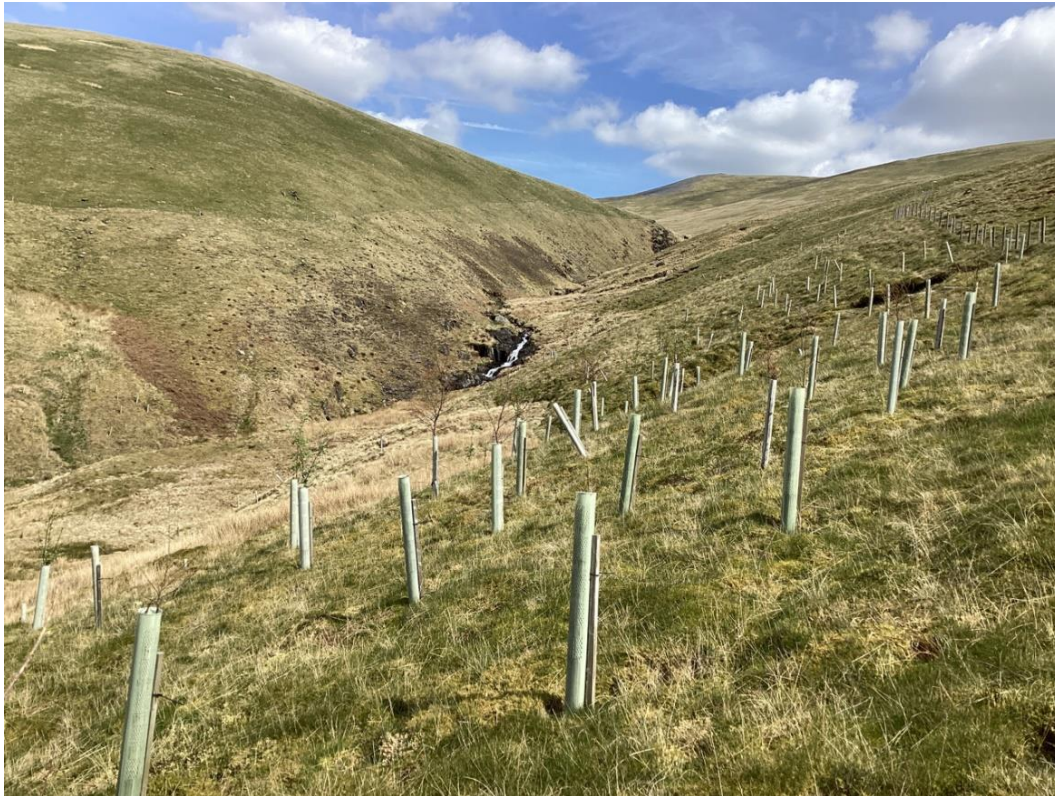
Reasonable survival of trees, some of these trees are more recent plantings. Few trees planted further up the gill and denser than intended at the top of slopes. Good heather growth on north slope.

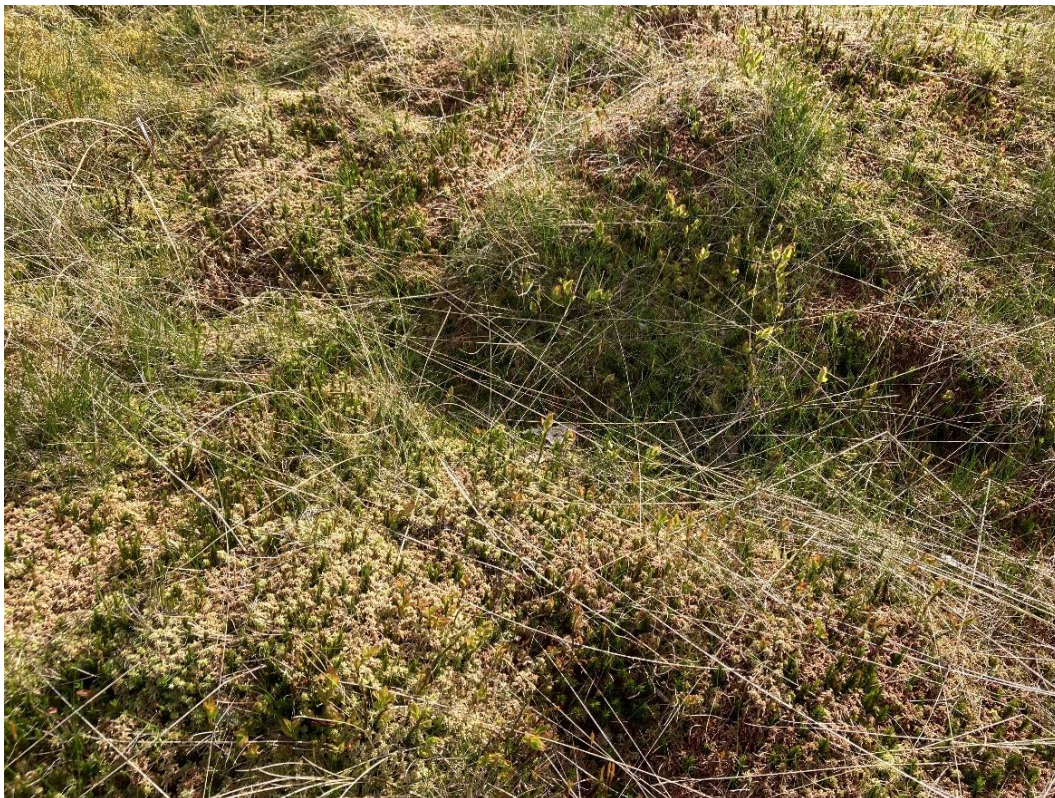
Development of thicker vegetation on the ground with mix of Sphagnum and other mosses and bilberry starting to establish.

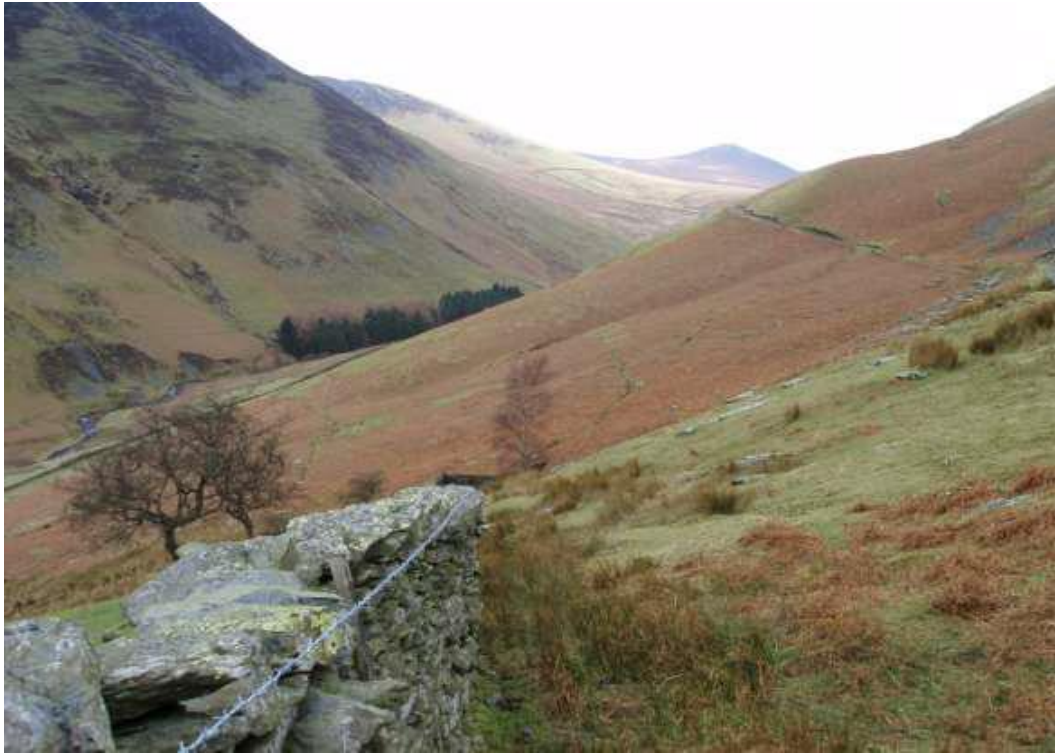
Photo from 2007, before planting and enclosure

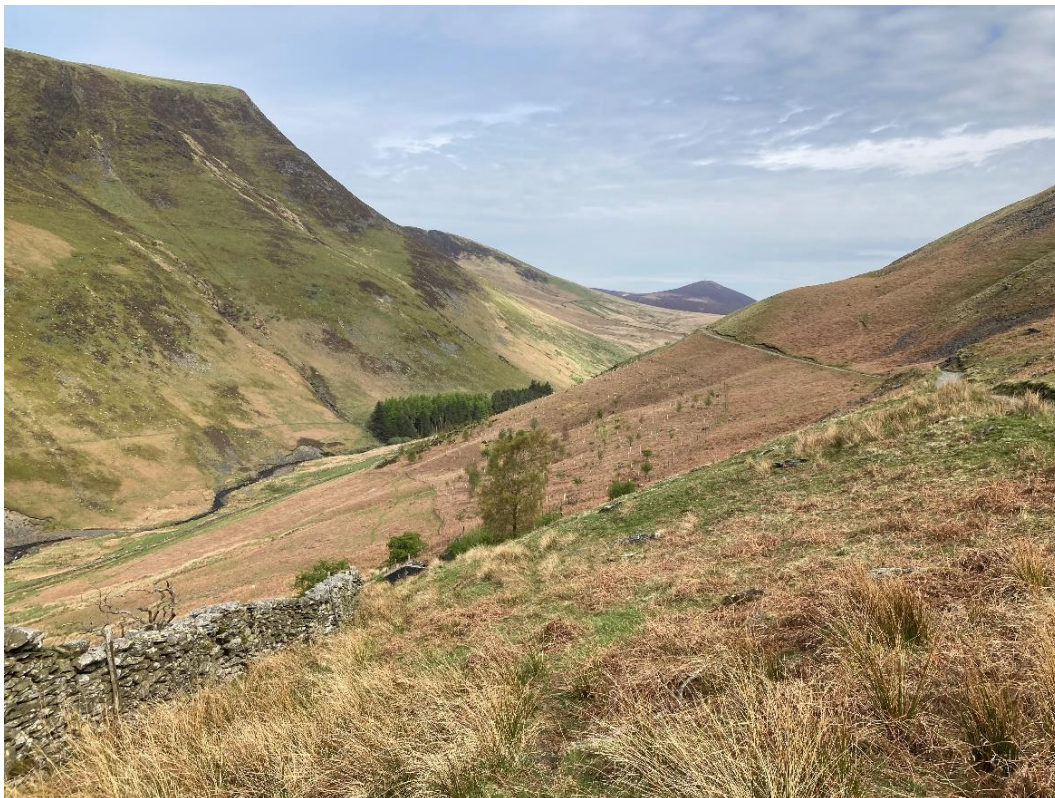
Similar view 2023, following 15 years of enclosure. Trees growing well.

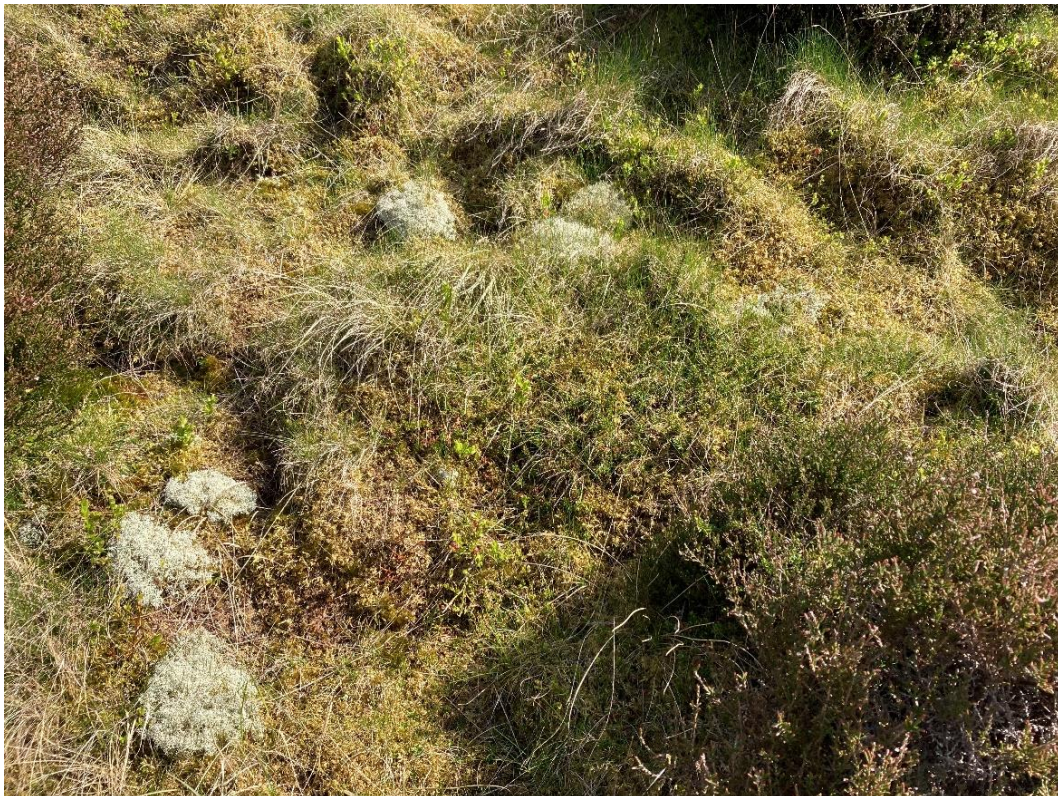
Vegetation development, including semi-mature and young growth heather, bilberry, mosses and lichens.

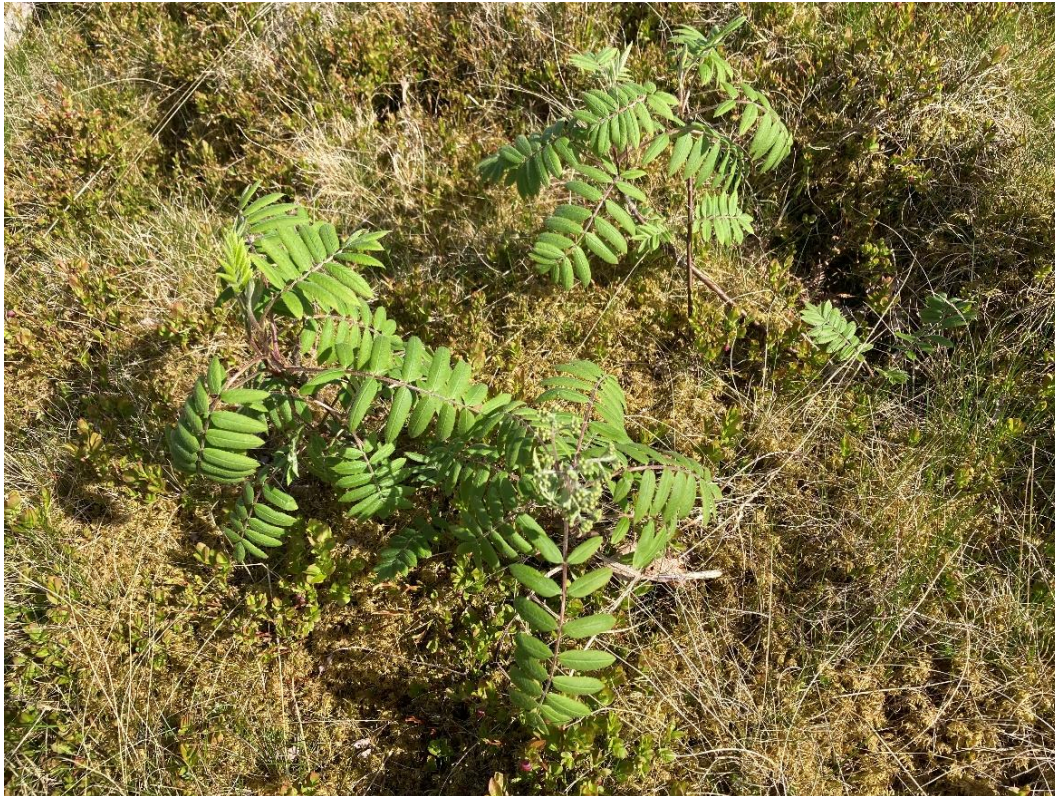
Natural regeneration of rowan

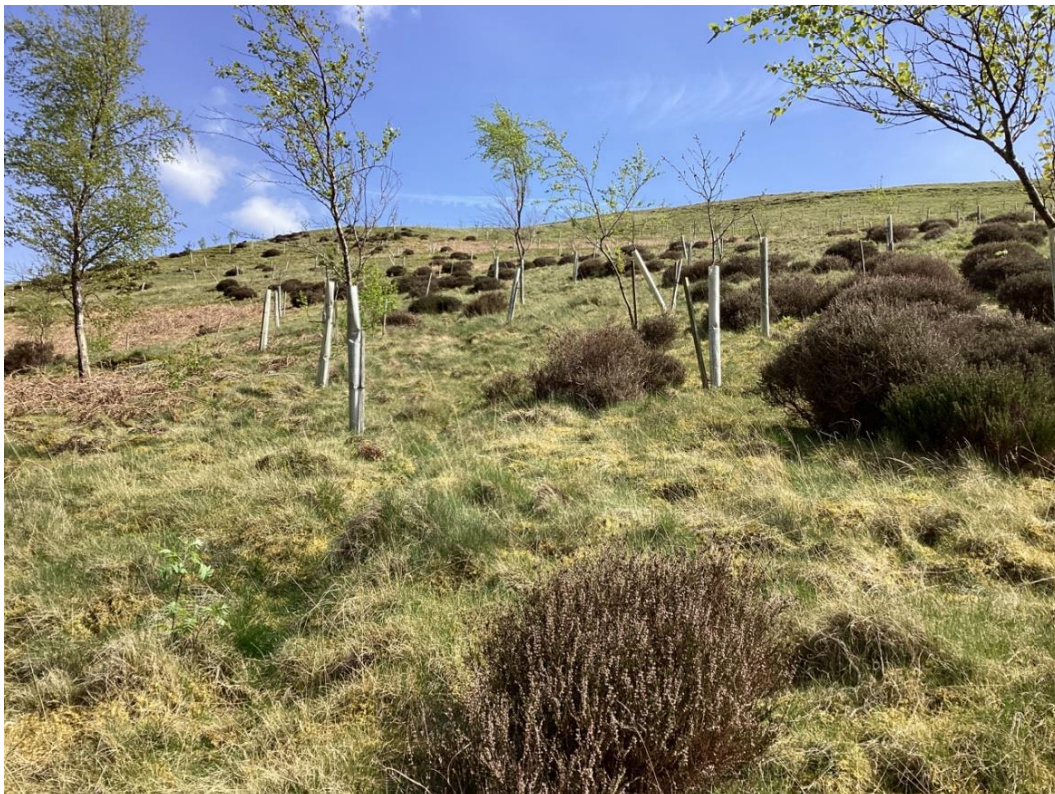
Mix of vegetation establishing in central area of enclosure with mosaics of dry heath growing well.

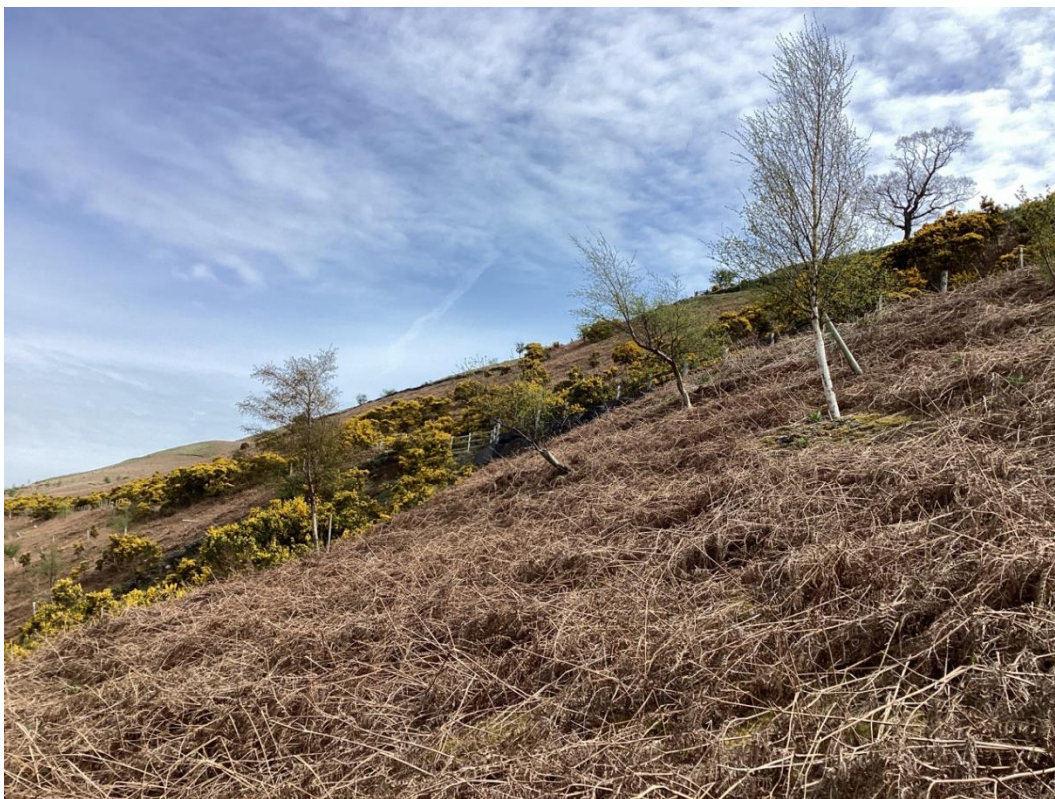
Strong tree growth in much of this enclosure

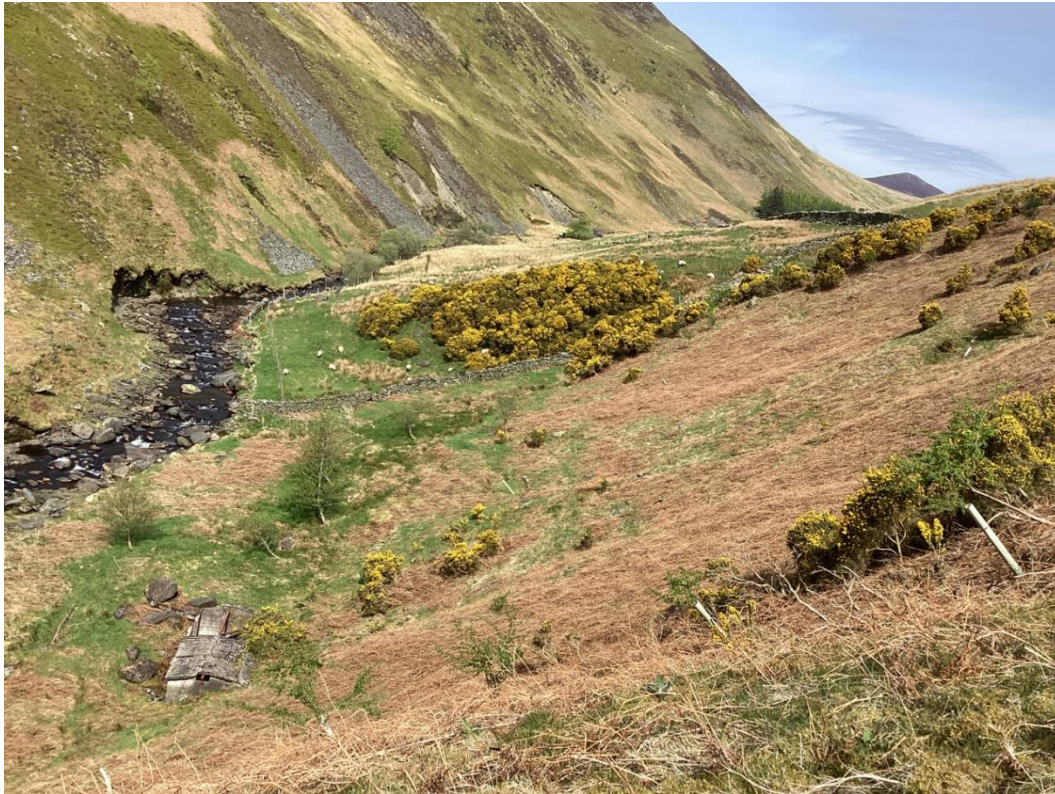
A large stand of bracken centrally in the enclosure has relatively few trees, additional trees should be planted here.

Areas of the enclosure with sparser planting to be restocked.

A large stand of bracken centrally in the Glendererra South enclosure has relatively few trees, the additional trees should be planted here.

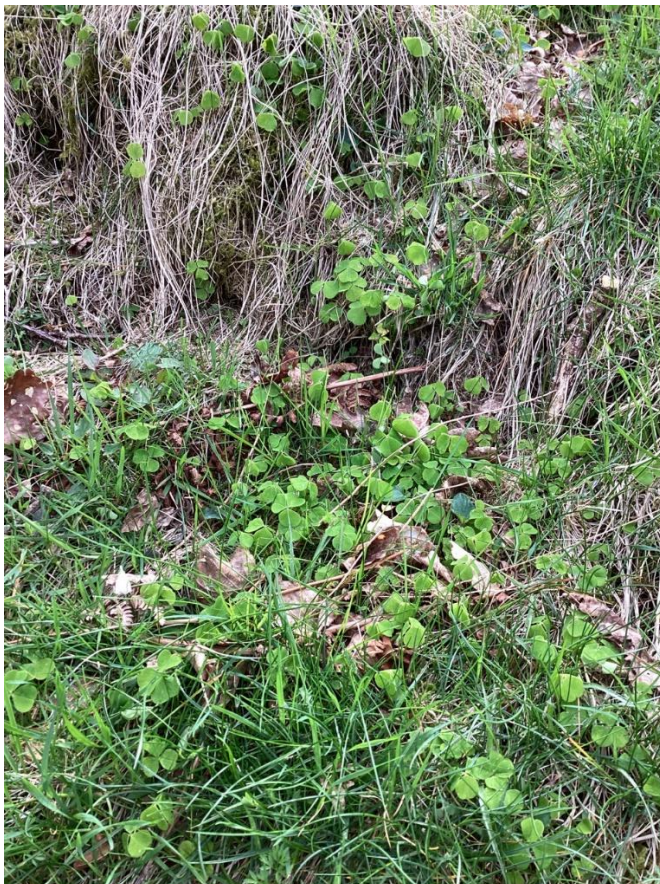
Developing ground flora includes wood sorrel and common dog violet, along with a thicker grass sward.

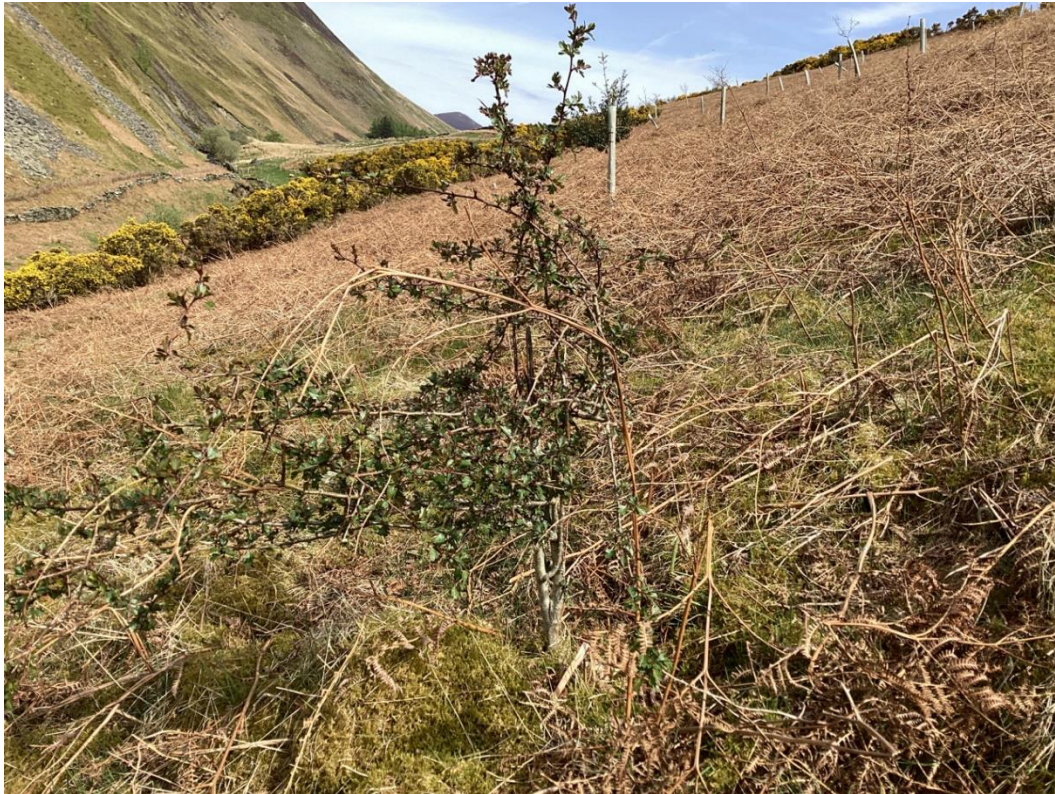
Hawthorn growing without stake and tube, likely self-sown, has a natural open form as a result of removal of grazing pressure.

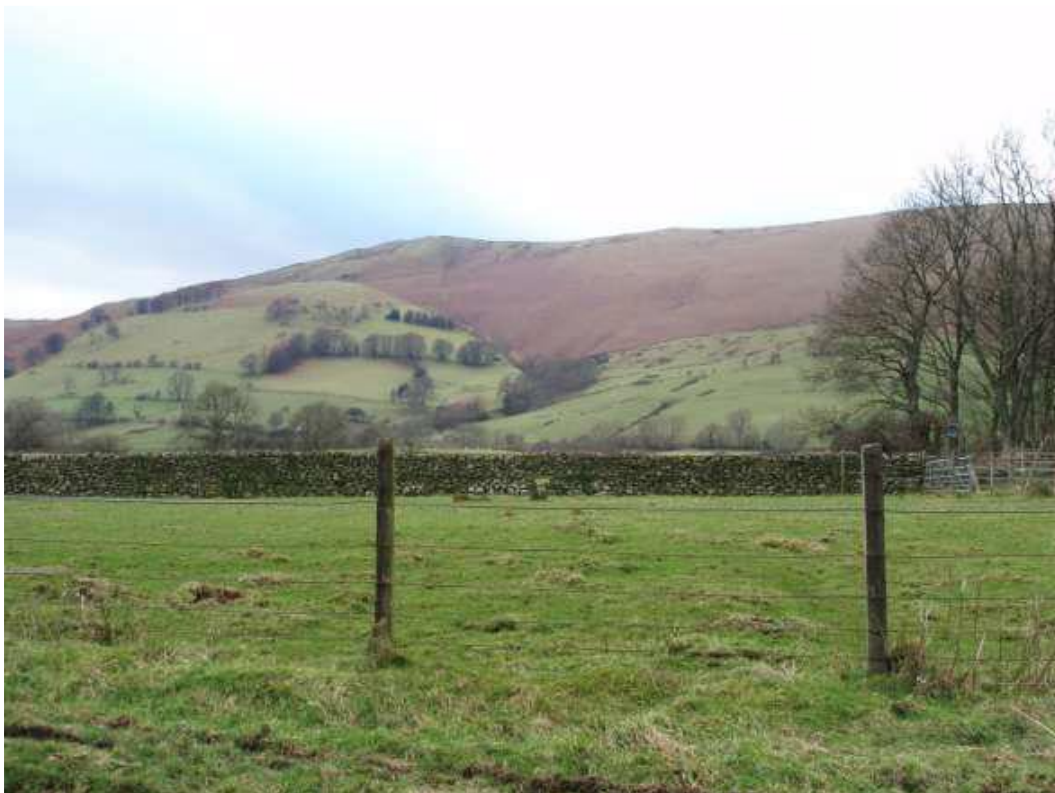
Photo from 2007, before planting and enclosure
