Review of areas fenced for tree and scrub regeneration on Mungrisdale, Saddleback and Bowscale Commons

Part of Skiddaw Group SSSI and the Lake District High Fells SAC

Natural England

June 2023

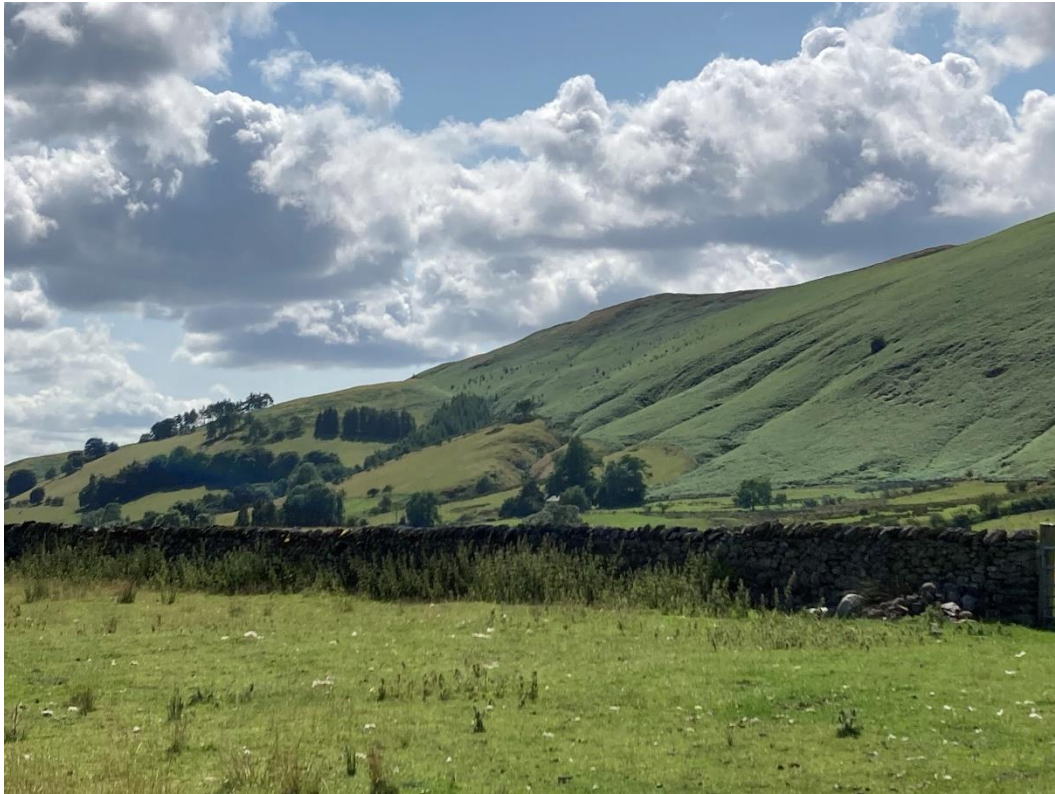
Similar view 2023, following 15 years of enclosure.

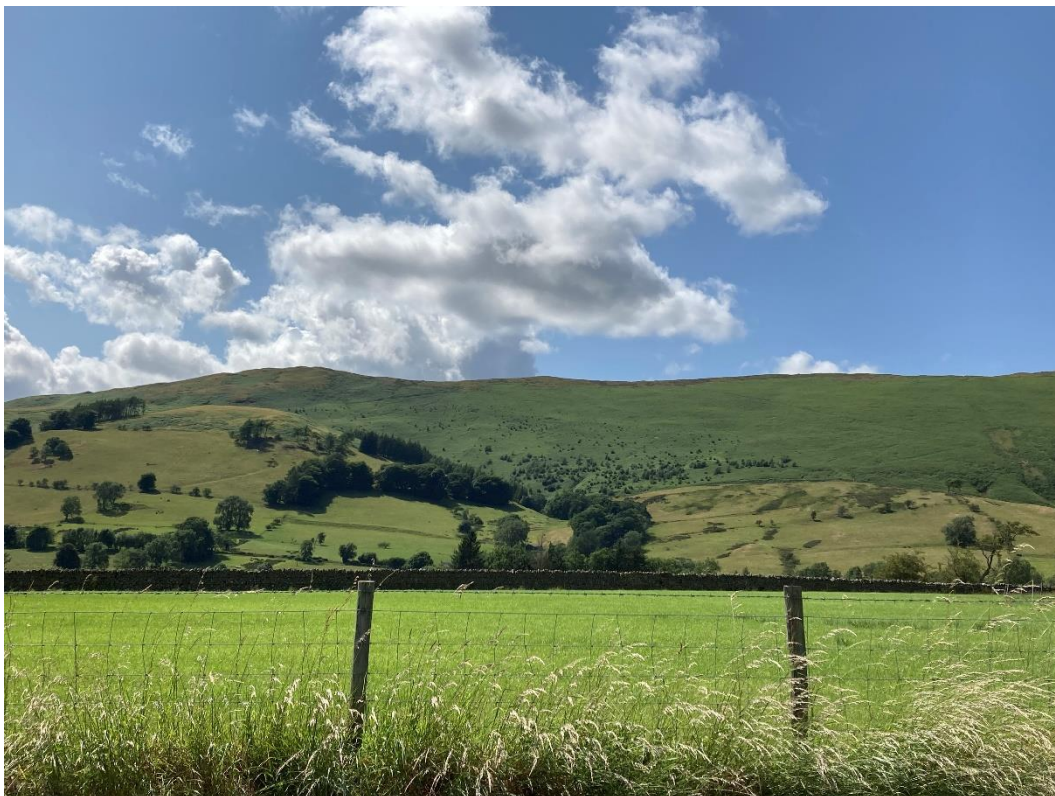
Trees within enclosure showing up fellside as a naturalistic extension of existing woodland.

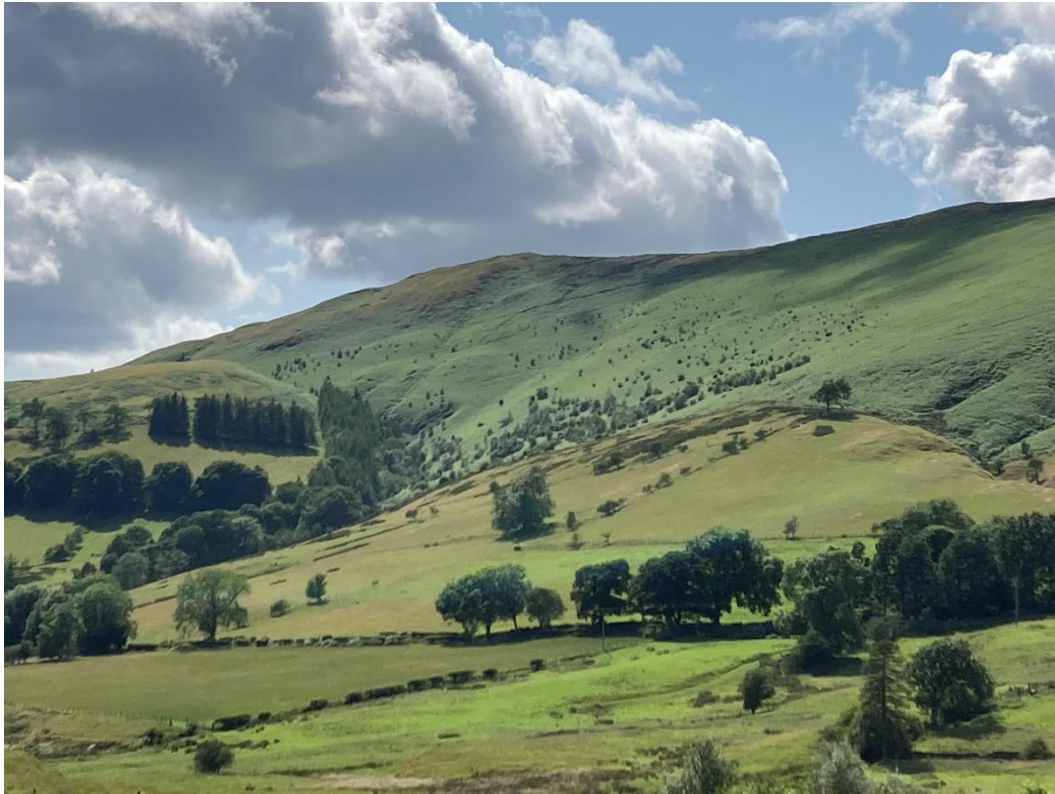
Good tree growth as seen from main road.

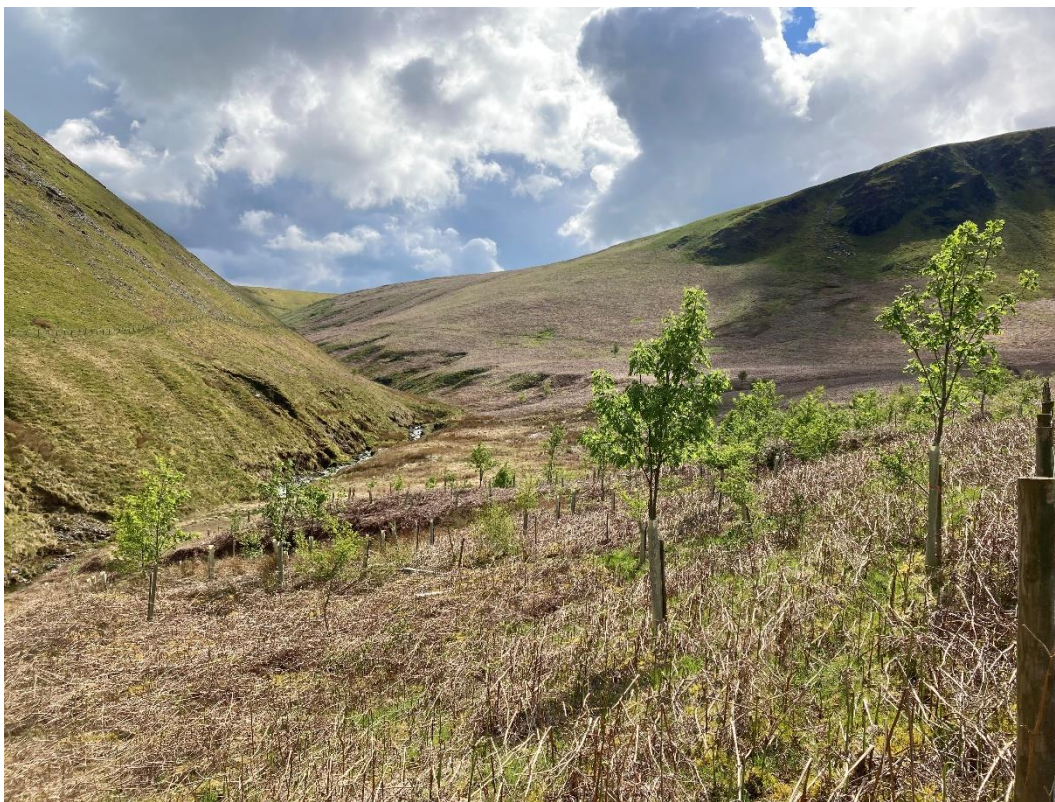
Good tree growth in areas of enclosure, particularly rowan and birch.

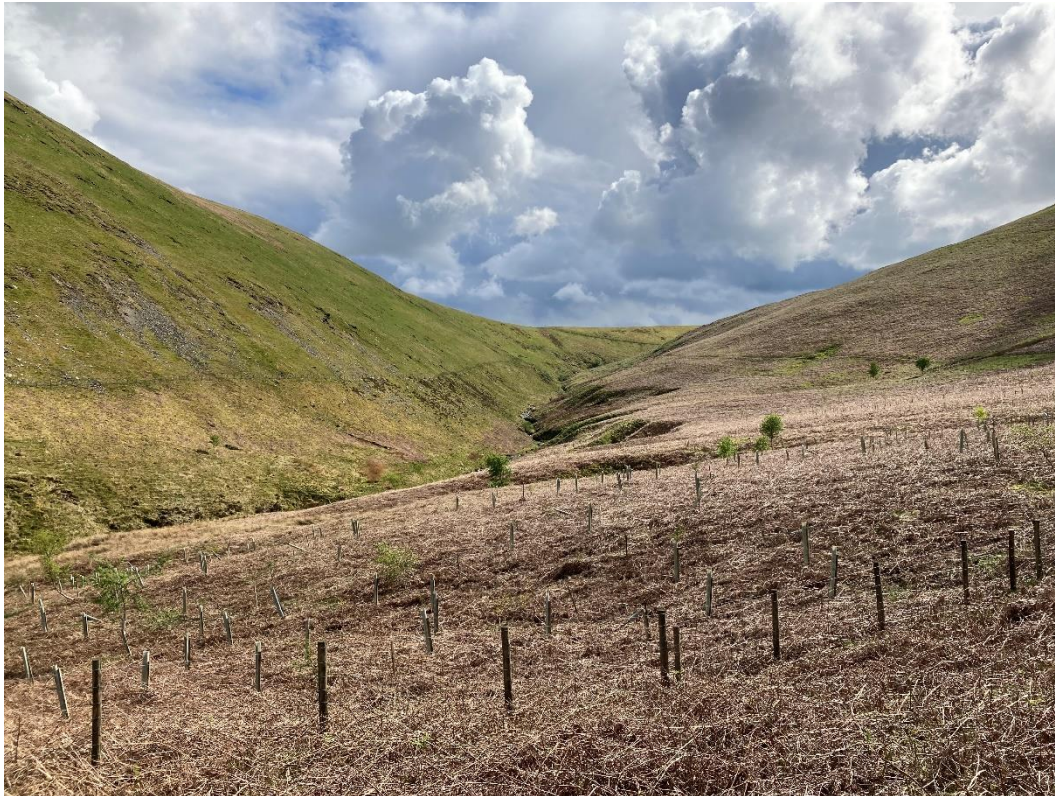
This enclosure has suffered the most from poor maintenance and stock ingress, for example on this visit the watergate appears to be partially open at the lower end and at least 6 sheep were in the enclosure. Survival rates of trees is low, in areas only about 20% of stake have a growing tree adjacent. It is unclear whether this can also be attributed to site conditions, such as soil and wind. There are areas where growth of trees is good, perhaps in more sheltered aspects. Species that have survived best are the usual early natural pioneers such as rowan, hawthorn and birch, many of these reach 3-4 m and are filling tubes. There is also occasional hazel and holly. Elsewhere in the enclosure the majority of tubes are fallen over and/or empty.

Poorer survival of trees and sparser planting further up glen. Heather can be seen establishing on East (left) slopes.

In the Glenderamackin enclosure replanting of pioneer species, such as rowan, hawthorn and birch, should be undertaken to replace those lost to stock ingress and poor maintenance. Planting should be focused on the more sheltered areas and north-west of the river where there has been some survival of previous planting.

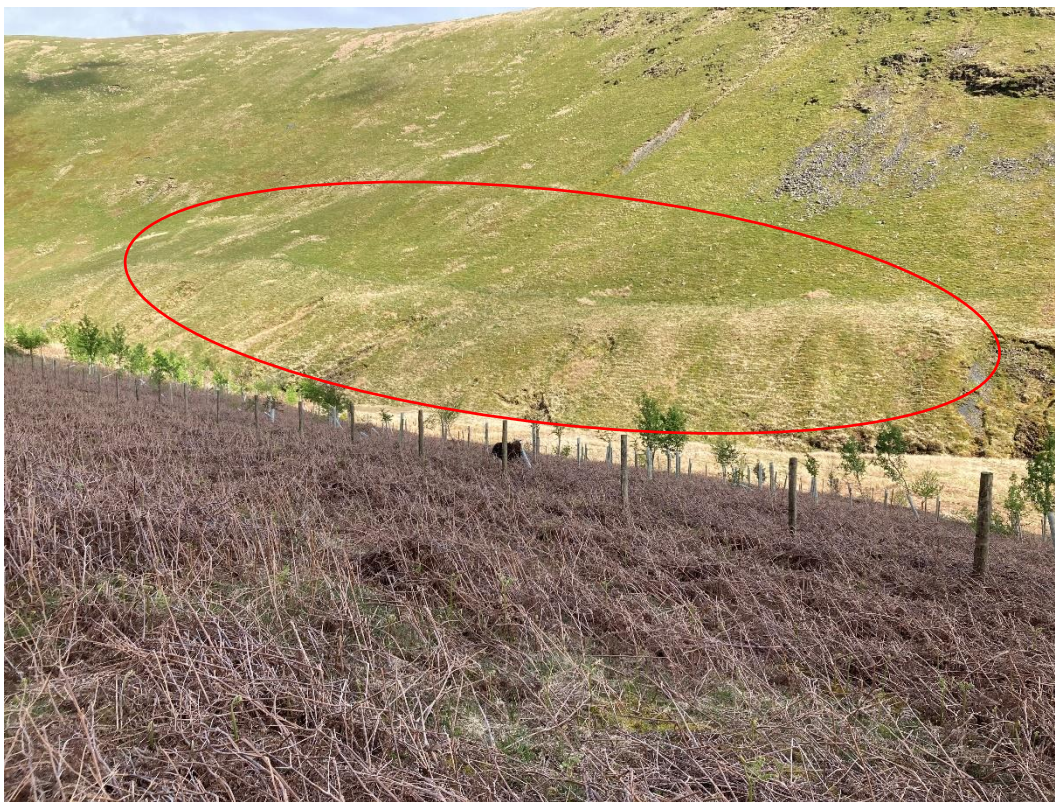
Sheep ingress has limited change within the enclosure, however a difference in vegetation below and above the fence line is still evident on the far side (East slopes). Thicker grass sward here will be controlling water and sediment runoff.
